# Beneath the Surface: Sustainable Solutions for Culvert Challenges and Water Management in a Community Garden

Community Leads: Ryan Cagle, Jordan Cagle. Community Scientist: Jack Montgomery.  
Community Science Fellow: Weijia (Emma) Liu

## Project summary and goals

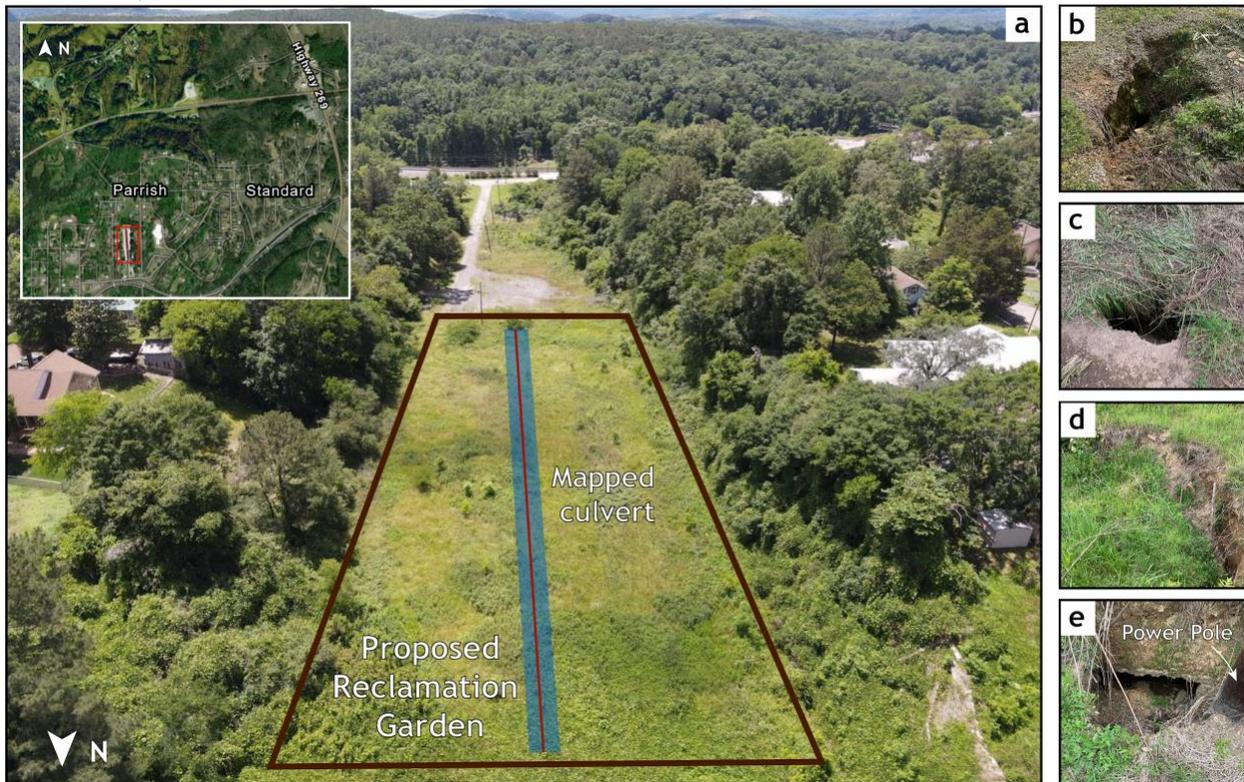
Figure 1. Site map overview. (a): The aerial view of the site. The proposed reclamation garden is shown in dark brown. The mapped culvert from site visit is shown as the red line. Exact location of the culvert can be found in the Past Work and Milestone section. (b) - (e): photo examples of sinkholes and land collapses.

The plan was to establish a community garden at the front end of the property and gradually develop the larger sections of the overall farm project. However, when planting began in 2023, a major sinkhole was discovered on the garden land, revealing a long-neglected culvert system beneath the surface. They are not currently maintained by any individuals or organizations. The project had to be halted due to these sinkholes and land collapses.

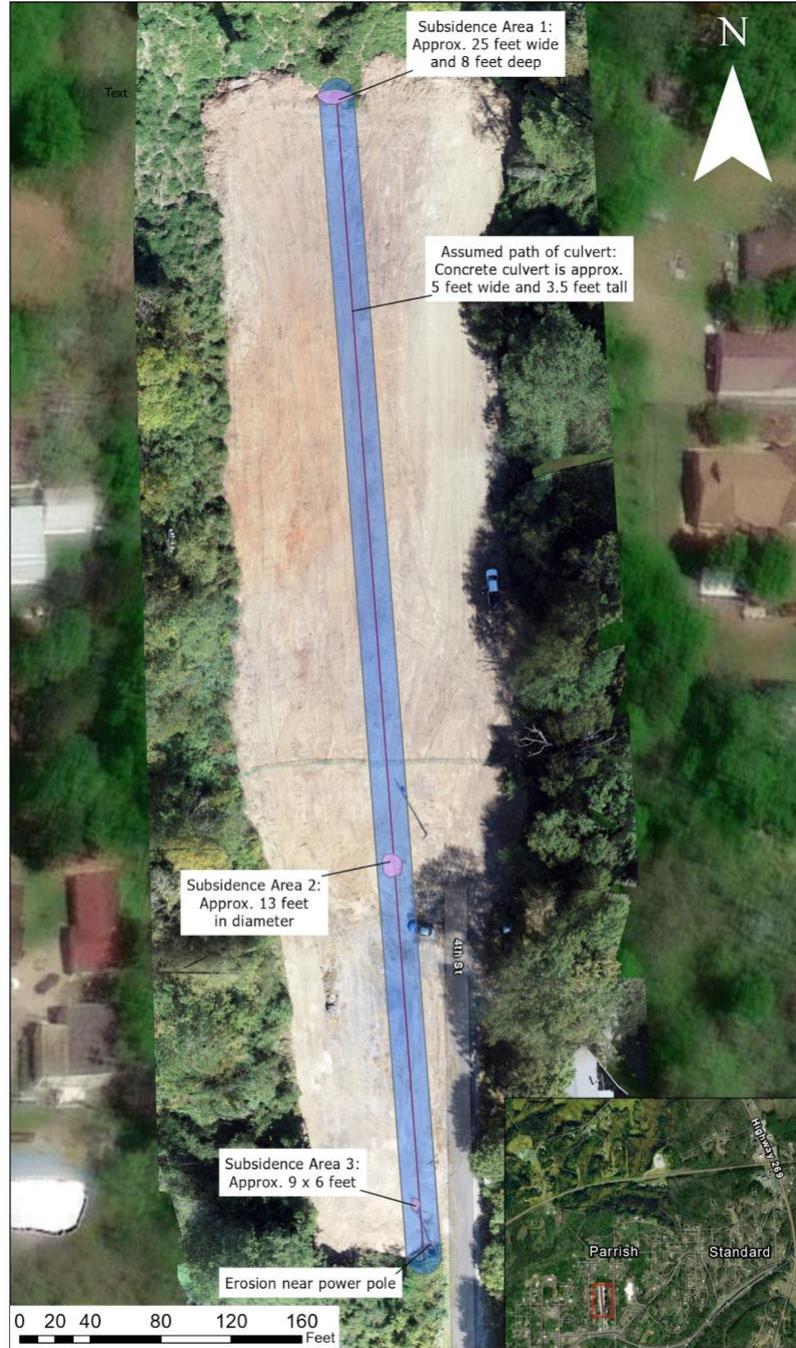
Figure 2. Site map of the culvert produced after the site visit on October 24, 2024

- A **rectangular culvert**, approximately **5 ft wide** and **4 ft tall** at the entrance, was identified running through the center of the site (marked in red in Fig. 2).
- No evidence of any other culvert.
- Three **main subsidence areas** (shaded in purple in Fig. 2) were noted, ranging in surface area from ~ **54 ft<sup>2</sup>** to **176 ft<sup>2</sup>**.
- An additional **erosion spot** was identified near the power pole located at the downstream end of the site.

Water continues to flow through the culvert from the rear opening toward the parking lot, indicating that it remains at least partially functional. However, the observed subsidence suggests potential **internal collapses** or **soil washout** within the culvert. Vegetation growing

near the holes may exacerbate these issues and should be cleared to allow further inspection and prevent additional root intrusion.

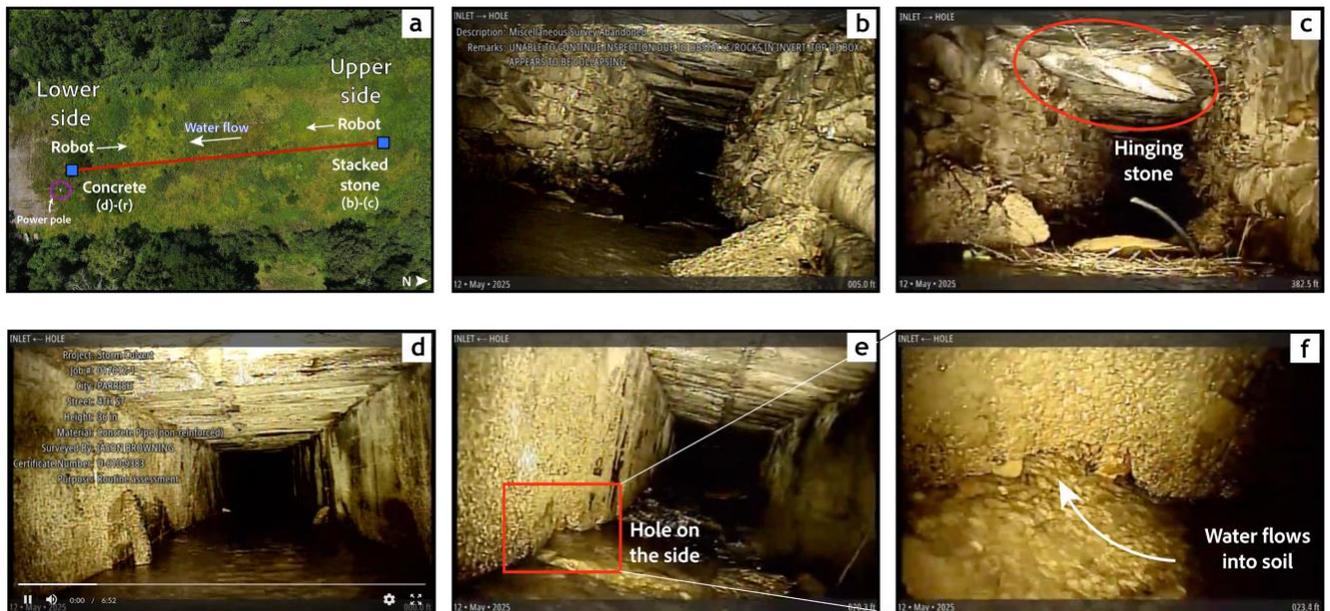
Figure 3. Overview of the video inspection. (a): map of the two inspections from the upper and lower sides of the culvert (red line). (b) - (c): images from the stacked stone section. The hinging stone from the ceiling of the culvert is circled in red. (d) - (f): images from the concrete section. The hole between the side and the bottom wall is highlighted in red.

- The culvert consists of **two construction sections**:
  - A **concrete section** on the lower side of the garden.
  - A **stacked-stone section** near the large hole on the upper side of the garden.
- A **hinging stone** in the stacked-stone section was observed to be dislodging downward, shown in Fig. 3 (c).
- A **hole ~ 23 ft** into the concrete section (between the side wall and bottom slab) allows **active water infiltration** into surrounding soils, shown in Fig 3. (e) - (f).
- Continuous water flow confirms that the culvert remains in active use.

The upper stacked-rock portion is likely older and more structurally compromised, while the concrete section may represent a partial replacement of an earlier failed culvert. Although the top of the concrete segment appeared intact, the hole along the wall joint is allowing water to undermine adjacent soil, contributing to gradual surface subsidence. This internal failure correlates spatially with the surface subsidence documented during the October 2024 site visit (Fig. 2). The stacked-rock section shows failure risk due to the loose hinging stone. A full replacement of the entire culvert is recommended.

Engage a hydrologist to calculate surface runoff rates and determine appropriate culvert dimensions for potential replacement. Excavation and replacement should be scheduled during the dry season to minimize risks.
