The Impact of Pumping and Sandbagging by the City of Lake Jackson on Flooding in the City of Richwood and other County Areas following Hurricane Harvey

Steven H. Emerman, Ph.D., Malach Consulting, LLC, 785 N 200 W, Spanish Fork, Utah 84660, USA, Tel: 1-801-921-1228, E-mail: SEmerman@gmail.com

Submitted to Matías J. Adrogué, PLLC, and Harrell & Nowak, LLC, on February 26, 2019

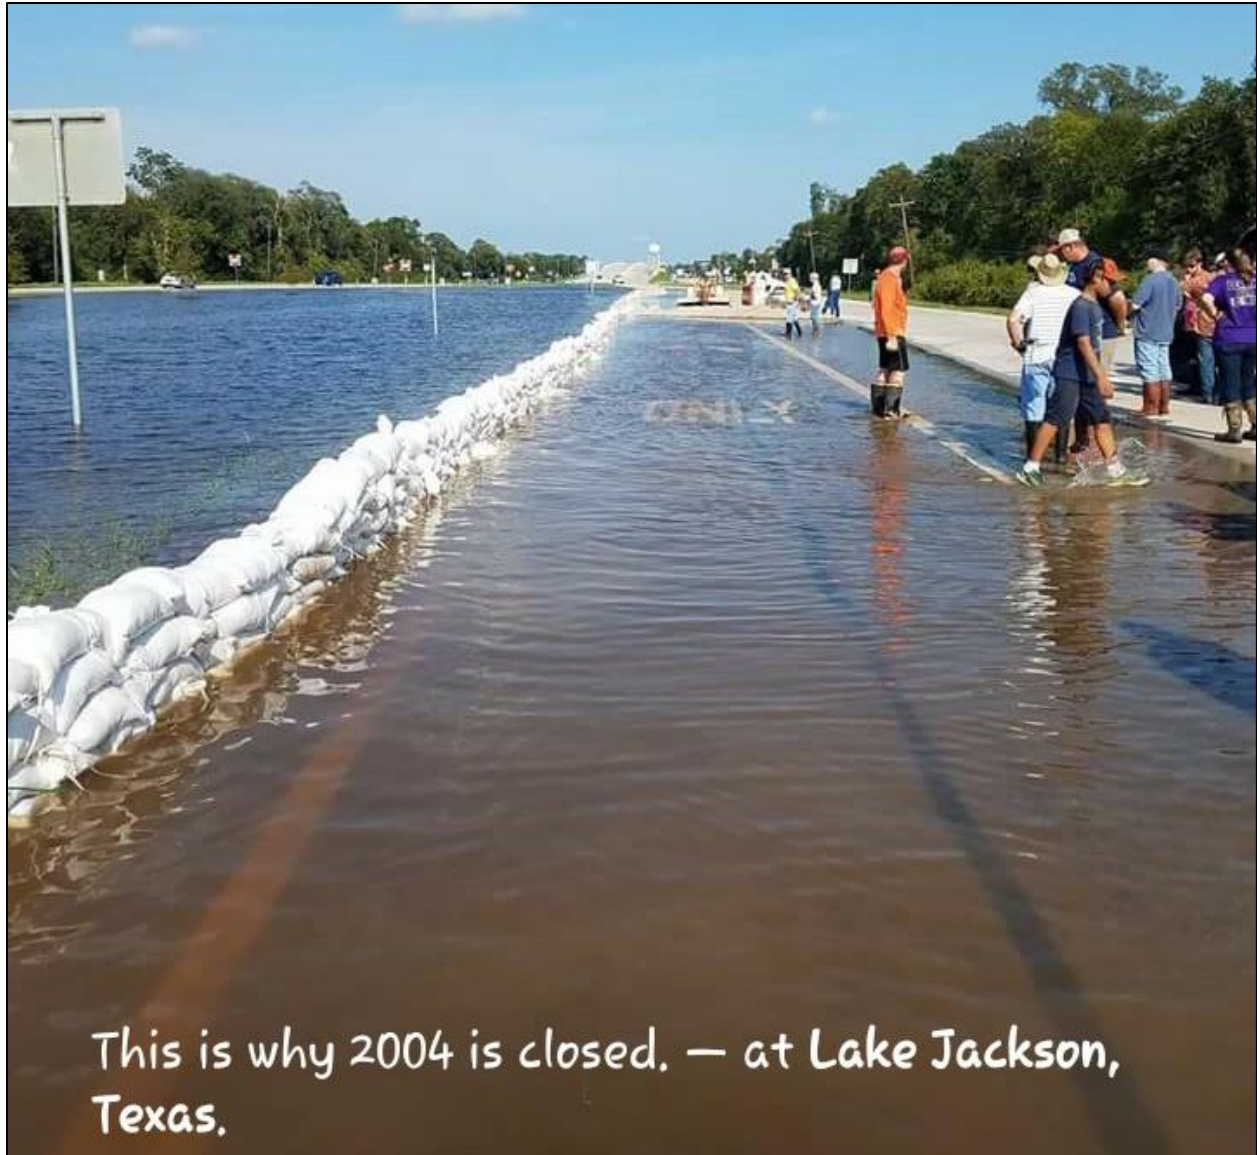
Figure 4a. A 24-inch high, 2000-foot long sandbag dam was constructed along the south side (eastbound lane) of FM2004 to prevent flooding of the city of Lake Jackson. View is looking east. Note FM2004 overpass over Old Angleton Road in background (see Fig. 3). Photo taken on or before September 3, 2017, and provided by Matías J. Adrogué, PLLC.

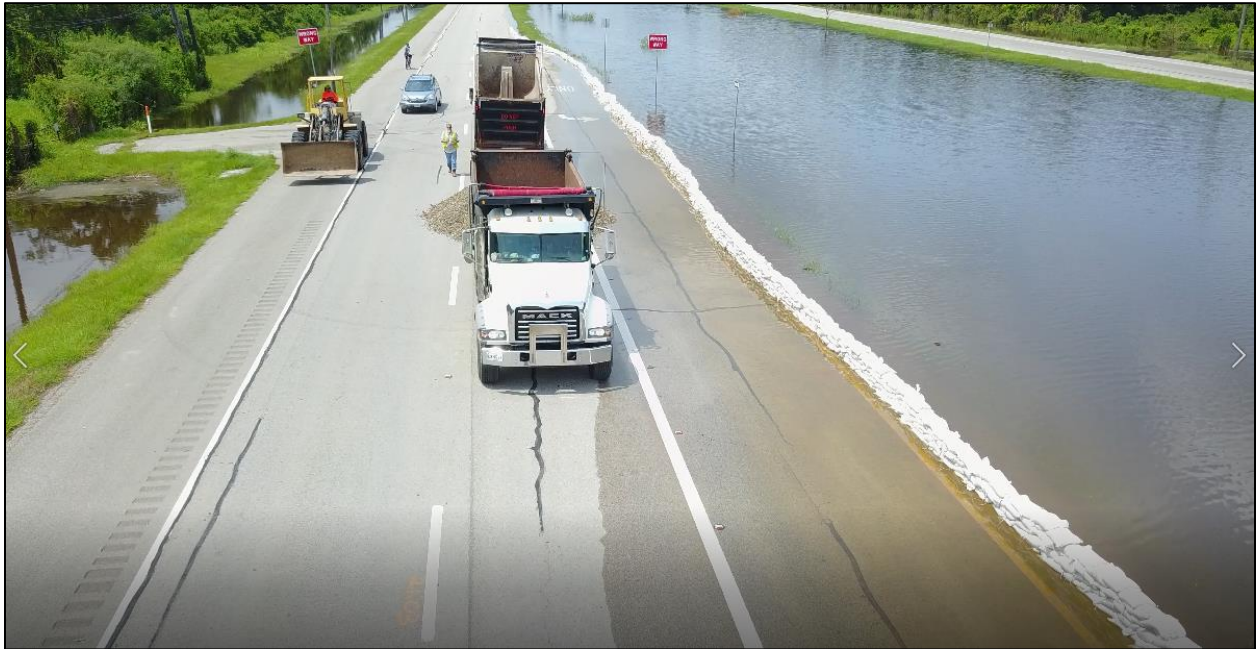
Figure 4b. A 24-inch high, 2000-foot long sandbag dam was constructed along the south side (eastbound lane) of FM2004 to prevent flooding of the city of Lake Jackson. View is looking west. Still shot at 1:00 of drone video labeled Before-8 taken on or before September 3, 2017, and provided by Matías J. Adrogué, PLLC.

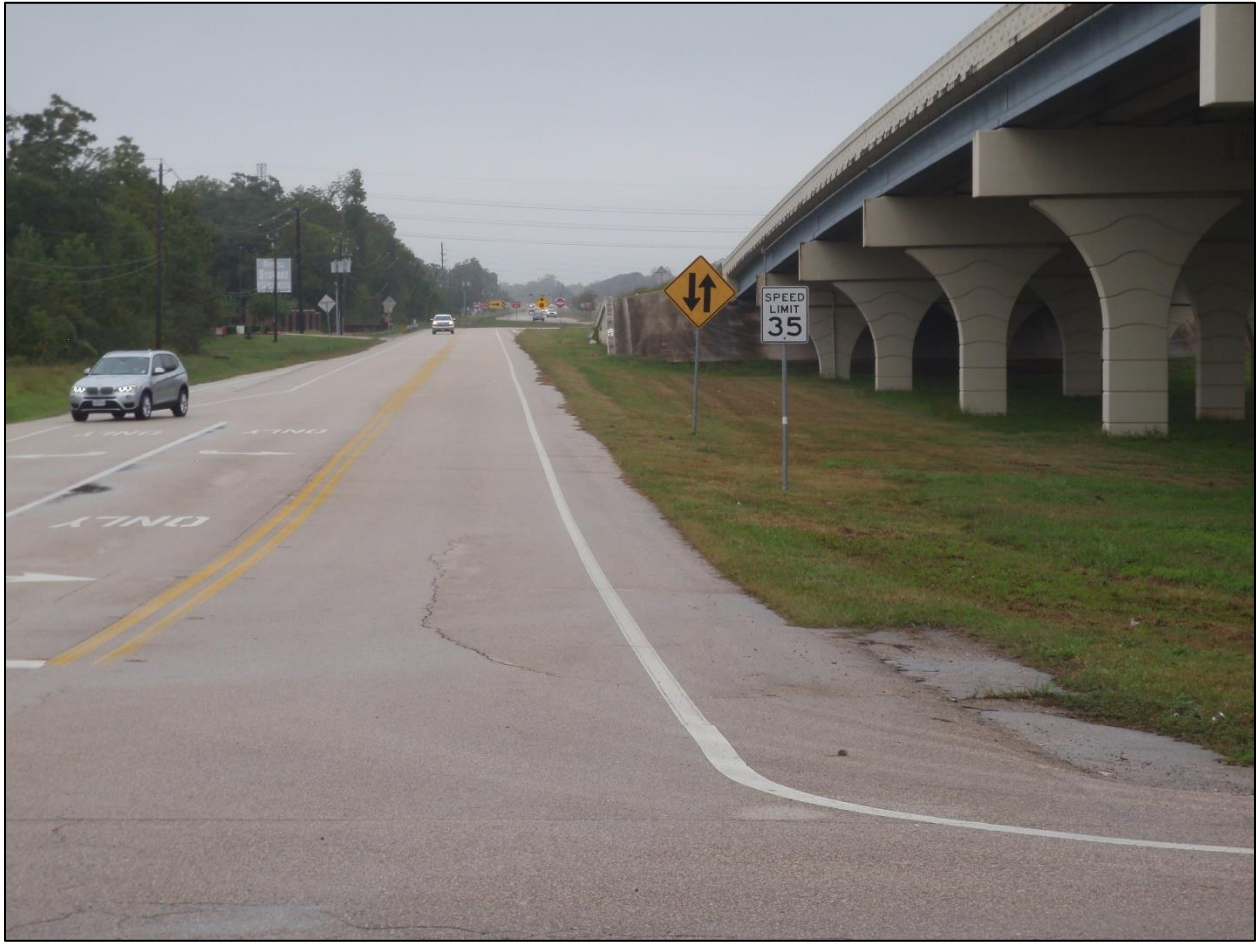
Figure 4c. Former site of 24-inch high, 2000-foot long sandbag dam that was constructed along the south side (eastbound lane) of FM2004 to prevent flooding of the city of Lake Jackson. View is looking to the west. The foreground is the intersection of Old Angleton Road (left to right) and the FM2004 south frontage road (foreground to background). The intersection was the easternmost limit of the sandbag dam (see Fig. 3), which was constructed on the north side of the south frontage road (middle right side of photo). Note the FM2004 overpass over Old Angleton Road to the right (see Figs. 3 and 4a) and the Do Not Enter sign on the FM2004 exit ramp in the background. Photo taken by the author on October 30, 2019.

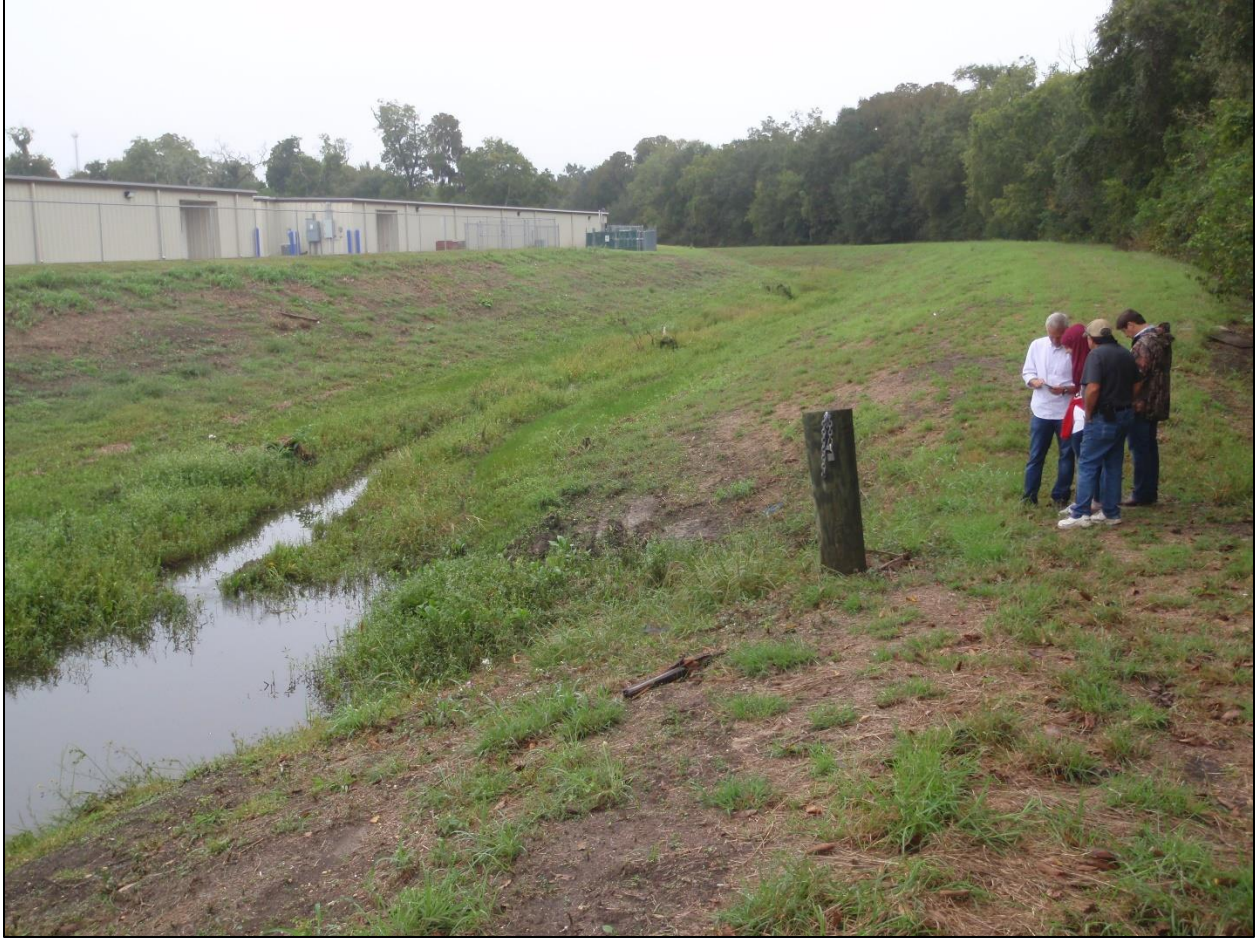
Figure 5a. Typically, water in the Brazos Canal (Slave Ditch) flows to the north toward Bastrop Bayou from south of FM2004 (see Fig. 3). View looking to the south on the south side of FM2004. Photo taken by the author on October 30, 2019.

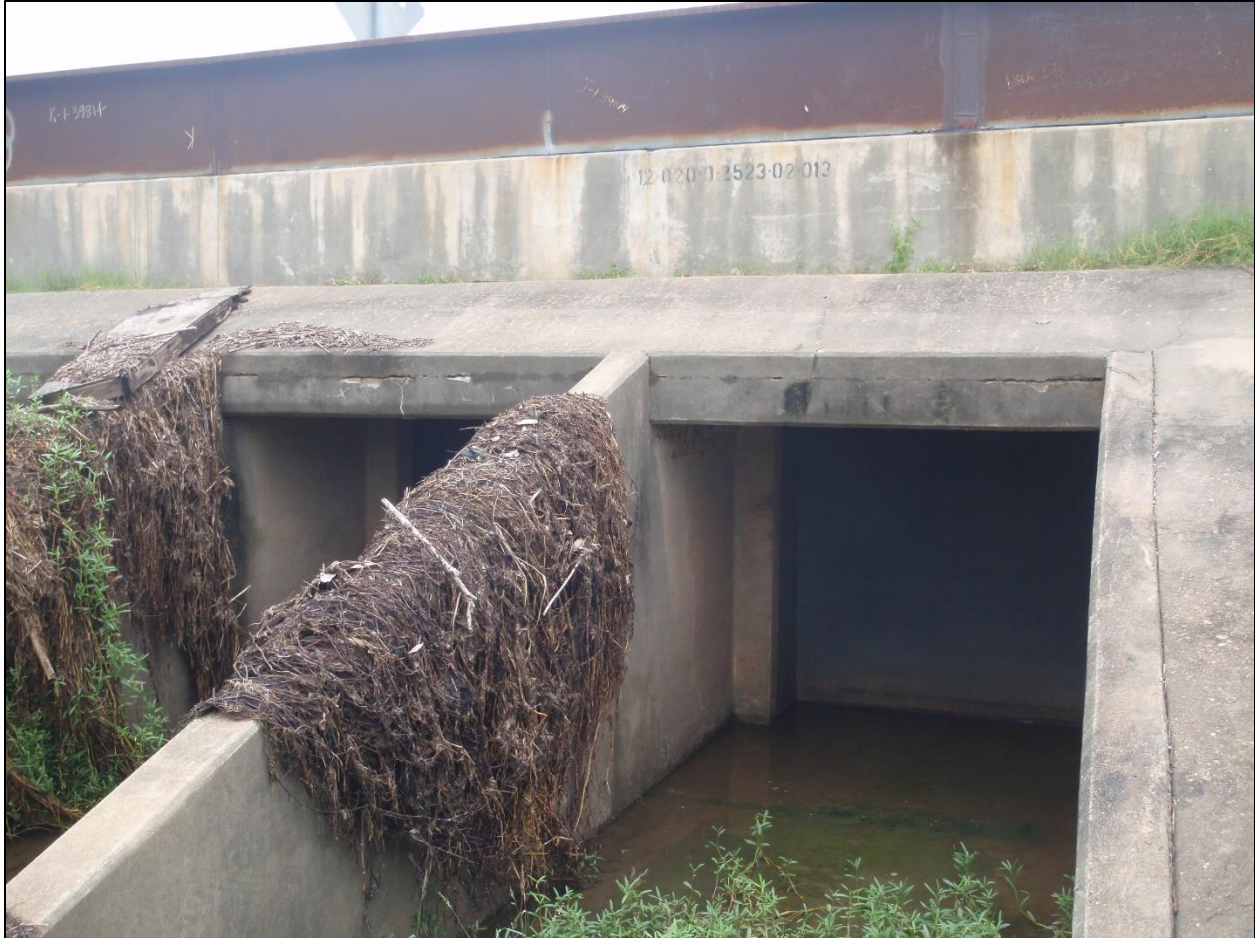
Figure 5b. Typically, water in the Brazos Canal (Slave Ditch) flows northward from the south side of FM2004 and through a set of three flap gates into a pumping chamber and then northward to Bastrop Bayou (see Fig. 3). View looking to the north. The purpose of the flap gates is to prevent water from flowing from the north through the Brazos Canal and into the city of Lake Jackson when Bastrop Bayou is at flood stage. From noon on August 28, 2017, until 4:50 pm on August 31, 2017, one of the flap gates was stuck open at a 45° angle, which allowed water to flow southward from Bastrop Bayou into the Brazos Canal south of FM2004. Photo taken by the author on October 30, 2019.

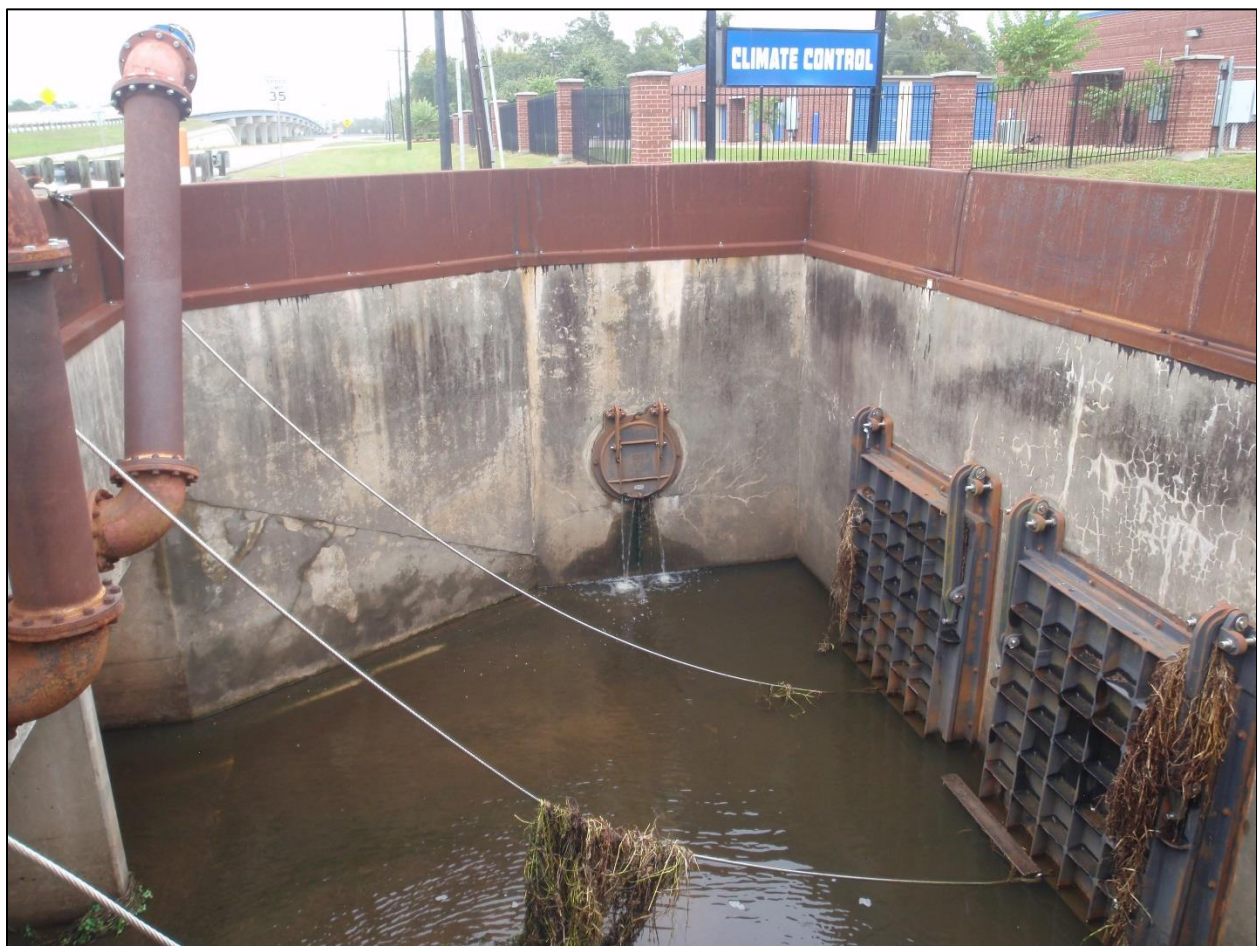
Figure 5c. Typically, water in the Brazos Canal (Slave Ditch) flows northward from the south side of FM2004, through a set of three flap gates into a pumping chamber, through culverts under FM2004, and then northward to Bastrop Bayou (see Fig. 3). View looking to the east. The purpose of the flap gates is to prevent water from flowing from the north through the Brazos Canal and into the city of Lake Jackson when Bastrop Bayou is at flood stage. From noon on August 28, 2017, until 4:50 pm on August 31, 2017, one of the flap gates was stuck open at a 45° angle, which allowed water to flow southward from Bastrop Bayou into the Brazos Canal south of FM2004. Note the cables for manual opening of the flap gates, the pipes on the left side for direct pumping into the Brazos Canal on the opposite (north) side of FM2004 (see Fig. 5d), and the FM2004 overpass in the left background (see Fig. 3). Photo taken by the author on October 30, 2019.

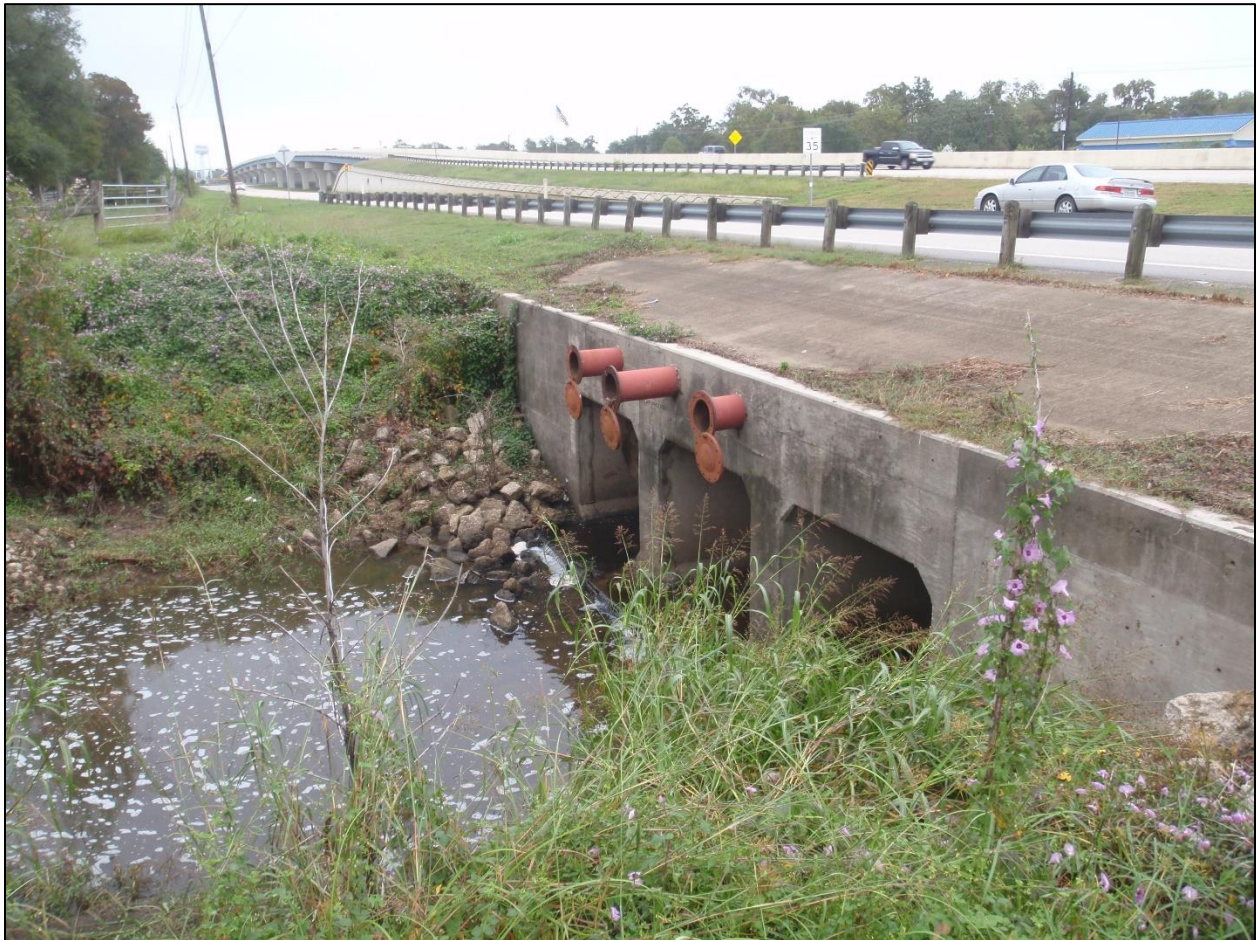
Figure 5d. Typically, water in the Brazos Canal (Slave Ditch) flows northward from the south side of FM2004, through a set of three flap gates into a pumping chamber, through culverts under FM2004, and then northward (to the left of the photo) to Bastrop Bayou (see Fig. 3). View looking to the east on the north side of FM2004. The purpose of the flap gates is to prevent water from flowing from the north through the Brazos Canal and into the city of Lake Jackson when Bastrop Bayou is at flood stage. From noon on August 28, 2017, until 4:50 pm on August 31, 2017, one of the flap gates was stuck open at a 45° angle, which allowed water to flow southward (to the right of the photo) from Bastrop Bayou into the Brazos Canal south of FM2004. In addition to the culverts, note the three pipes for direct pumping of water into the Brazos Canal (see Fig. 5c). Photo taken by the author on October 30, 2019.

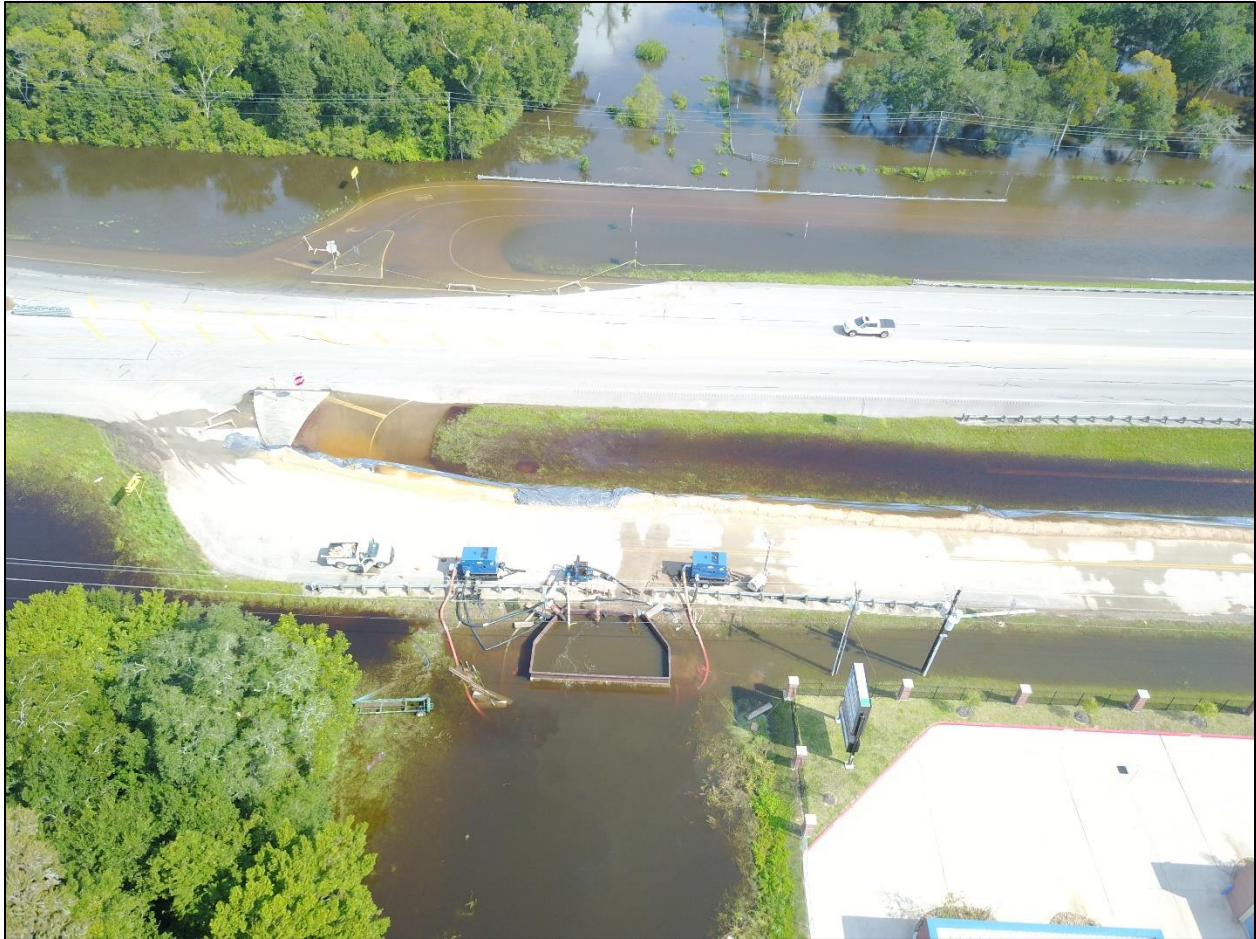
Figure 5e. Typically, water in the Brazos Canal (Slave Ditch) flows northward (from top to bottom in photo) from the south side of FM2004, through a set of three flap gates into a pumping chamber, through culverts under FM2004, and then northward to Bastrop Bayou (see Fig. 3). Note the three large blue pumps that are pumping water from the Brazos Canal and into the pumping chamber in order to force the water to flow northward through the culverts. The purpose of the flap gates is to prevent water from flowing from the north through the Brazos Canal and into the city of Lake Jackson when Bastrop Bayou is at flood stage. From noon on August 28, 2017, until 4:50 pm on August 31, 2017, one of the flap gates was stuck open at a 45° angle, which allowed water to flow southward out of the pumping chamber into the Brazos Canal south of FM2004. Based on the minimum drop in water level of one foot from the north to the south side of the flap gates (equivalent to the drop in water level from the inside to the outside of the pumping chamber), Grounds (2019) showed that water was flowing out of the pumping chamber southward into the Brazos Canal faster than it was being pumped into the pumping chamber. On that basis, the high water level in the pumping chamber resulted not from the pumping, but from the southward flow through the culverts. Still shot of drone video taken on or before September 3, 2017, and provided by Matías J. Adrogué, PLLC.

Figs. 1-3). Subsequent to the actions of the City of Lake Jackson, flooding occurred in the city of Richwood to the east and in other county areas outside of Lake Jackson (see Fig. 3). The 24-inch high, 2000-foot long sandbag dam was constructed across the south side (eastbound lanes) of FM2004 and the north side of the FM2004 south frontage road, and was in place from August 31 to September 3, 2017 (see Figs. 4a-c). The pumping was carried out in an attempt to transfer water from the Brazos Canal (also called Slave Ditch) into Bastrop Bayou (see Fig. 3). The Brazos Canal typically flows northward into a pumping chamber that is south of FM2004, through culverts that pass under FM2004, and then northward to Bastrop Bayou (see Figs. 3, 5a-d). However, when Bastrop Bayou is at flood stage, water could flow in the opposite direction, that is, southward from Bastrop Bayou, through the culverts under FM2004, and into the pumping chamber (see Figs. 3, 5c-d). The pumping chamber includes three flap gates that allow water to flow only northward, so that water from Bastrop Bayou cannot flow southward through the Brazos Canal into Lake Jackson (see Fig. 5c). From August 27 until September 11, 2017, five pumps were used to transfer water from the Brazos Canal into the pumping chamber in an attempt to force the water to flow into the culverts and northward across the highway (see Fig. 5e).

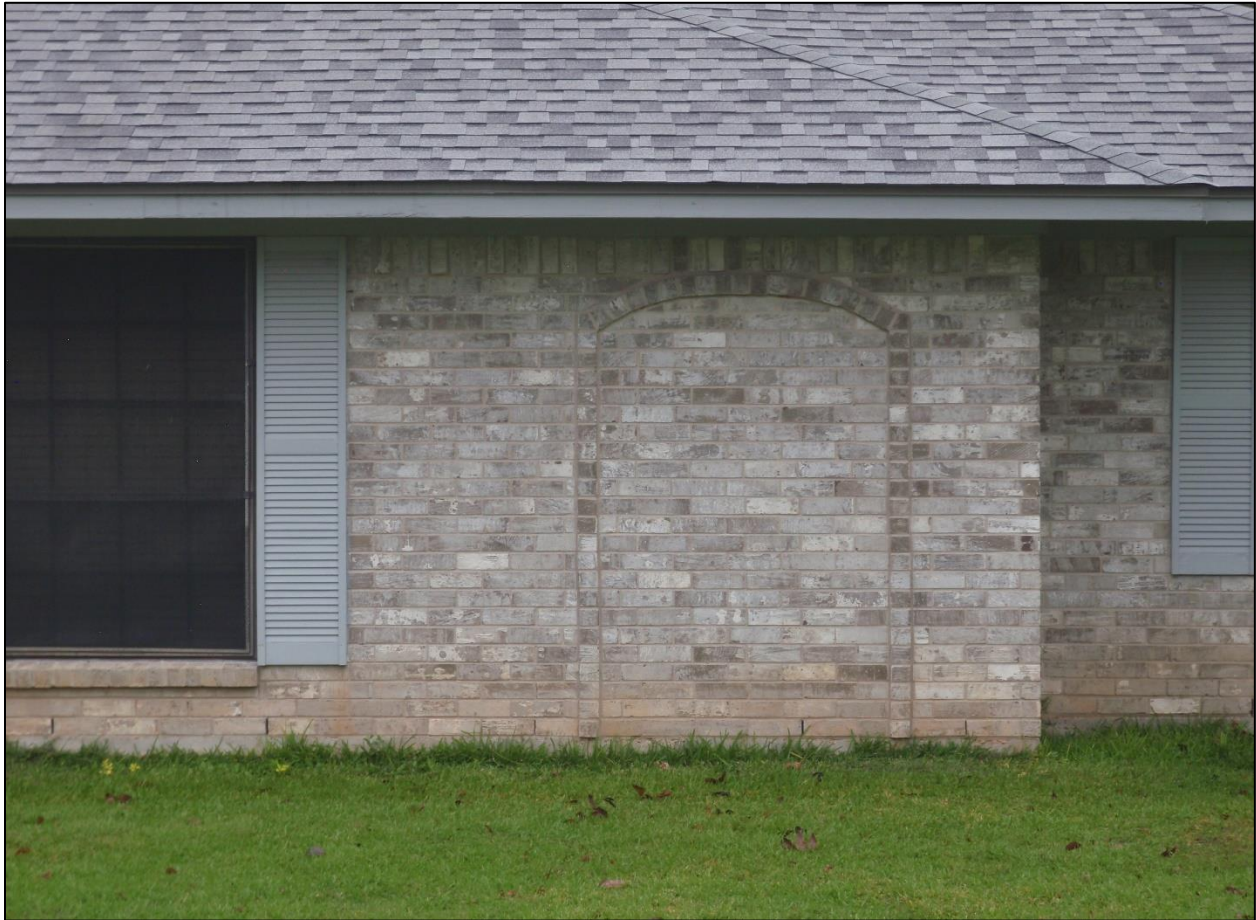
Figure 7a. Homes in Richwood and adjacent county areas that were not power washed after the flood still show watermarks about two feet above the ground surface. Photo shows the home at 14 Sherwood Drive. Photo taken by the author on October 30, 2019.

watermarks about two feet above the ground surface (see Fig. 7a). The fence in the backyard of 12 Sherwood Drive (property of Kevin McKinney) just outside of Richwood showed a watermark below which light-grayish lichens had been removed by the flood water (see Figs. 7b, 8). The average watermark along the fence was measured at 24 inches above the ground surface. Since the Lidar-based DEM (StratMap, 2018a) gave a ground elevation of 11.42 feet at the same location, the maximum water-surface elevation at the location was determined to be 13.42 feet (see Table 1). It should be noted that both the new Lidar data (StratMap, 2018a-b) and the elevations reported by Grounds (2019) were based on the same definition of sea level (NAVD88, Geoid 12B) (AECOM, 2018).

Although sufficient water was diverted to flood the affected areas to a depth of 46 feet, those areas were flooded to an average depth of only two feet (see Figs. 7a-b). Flooding the affected areas to a depth of 46 feet would require that all of the flood water remain in the affected areas with none of the diverted water returning to Bastrop Bayou. However, diverting enough water to flood the affected areas to a depth of 46 feet with an actual flooding depth of

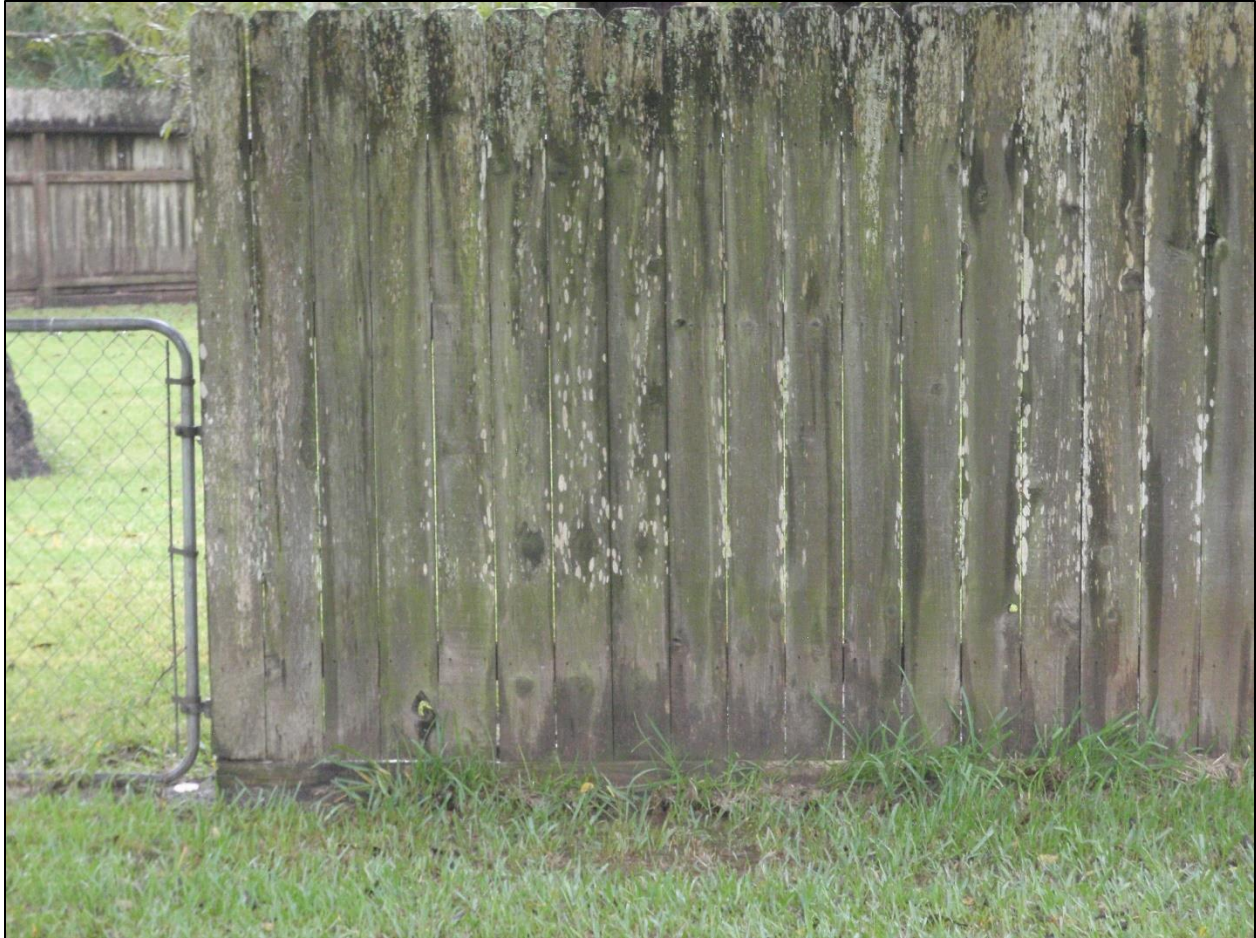
Figure 7b. The fence in the backyard of 12 Sherwood Drive (property of Kevin McKinney) just outside of Richwood shows a watermark below which light-grayish lichens were removed by the flood water. The average watermark along the fence was measured at 24 inches above the ground surface. Photo taken by the author on October 30, 2019.

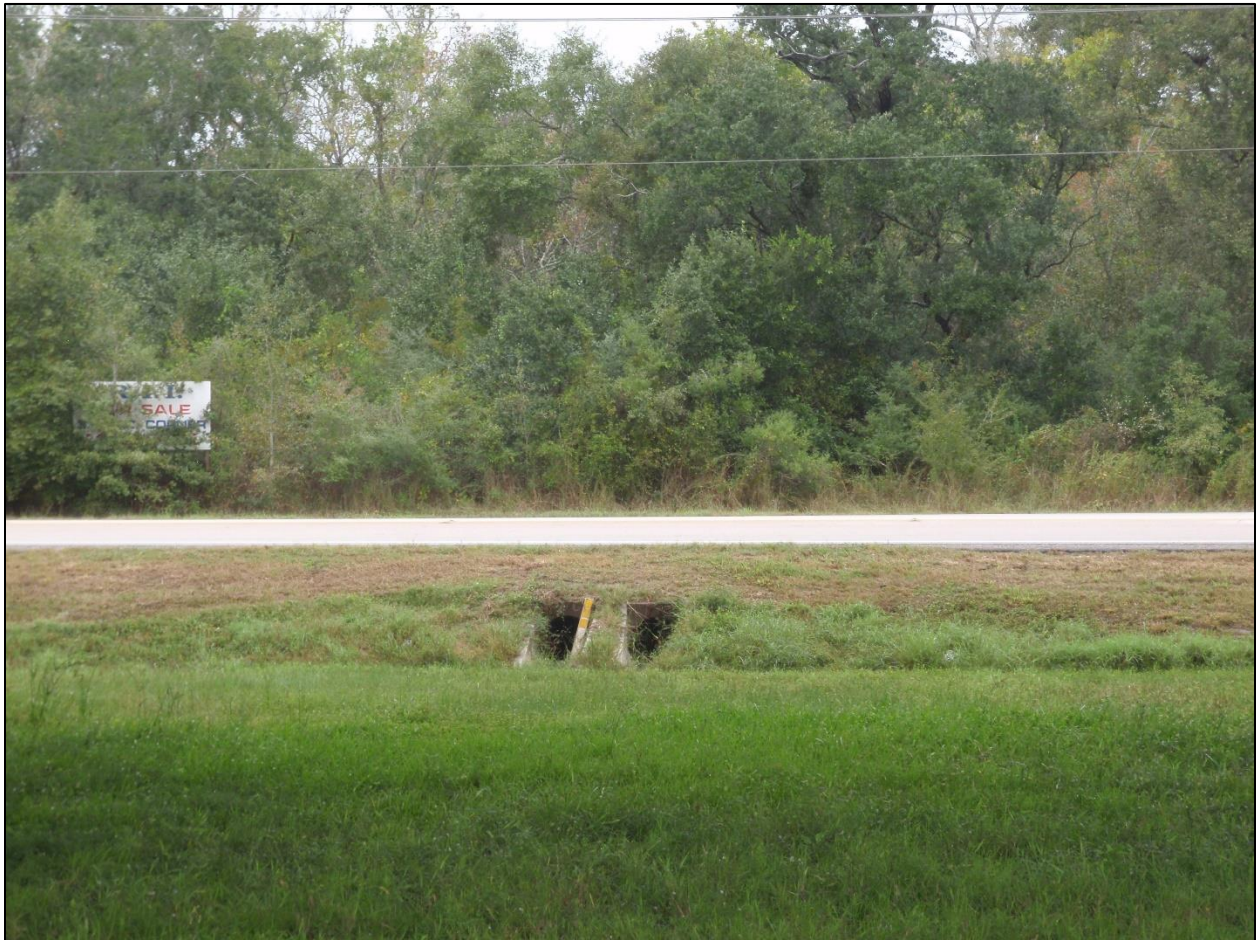
Figure 12. During the overflow from Bastrop Bayou, water most likely flowed southward through the culverts underneath the north side (westbound lanes) of FM2004 before ponding against the sandbag dam that was constructed on the south side (eastbound lanes) of FM2004 (see Figs. 3, 4a-c). View looking to the north under the FM2004 overpass over Old Angleton Road (see Fig. 3) from a site slightly west of the site of Fig. 4c. The median strip is visible in the foreground with the FM2004 north frontage road in the middle ground. Note that flood water mostly did not flow across FM2004, but flowed under the highway and ponded in the median strip (see Figs. 4a-b, 5e, 9). Photo taken by the author on October 30, 2019.

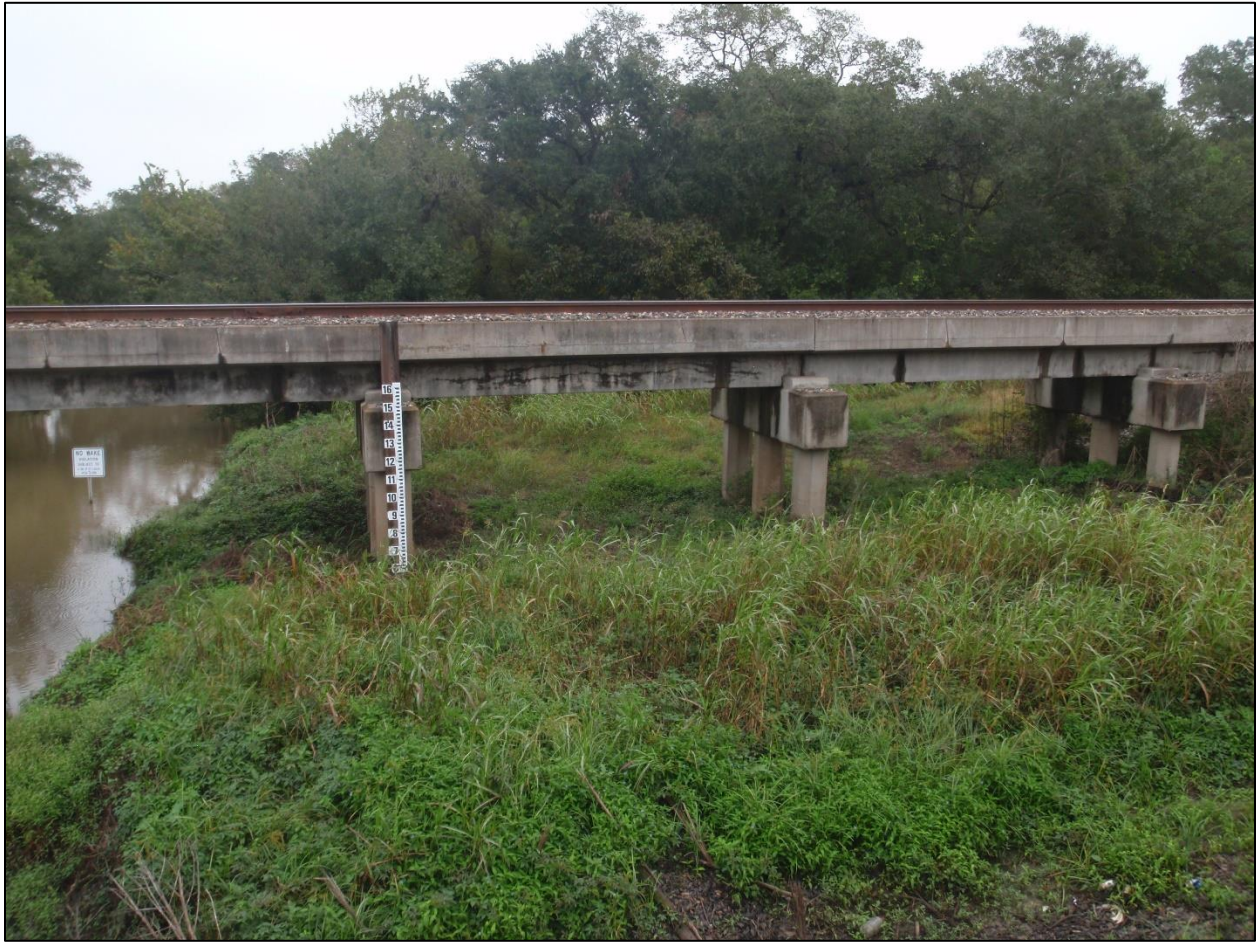
Figure 13. It is most likely that the flood water crossed the railroad under the bridge over Bastrop Bayou on the south side (right side of photo) of the bayou (see Figs. 10-11). View looking downstream to the east. Note the stream gage bolted to the bridge. Photo taken by the author on October 30, 2019.

The second step was the spillage of the pond to the east under the southern portion of the railroad bridge (see Figs. 10, 11, 13). This flood water would have been confined to the southern portion of the bridge because it could not have entered Bastrop Bayou, which was at a higher water-surface elevation. For the same reason, the third step was the passage of the flood water to the northeast, in the general downstream direction of Bastrop Bayou, but confined to the southern (or southeastern) floodplain of the bayou (see Figs. 10-11). Note that the water-surface elevations reported by Grounds (2019) do not refer to the stream gage that is visible in Fig. 13, since Grounds (2019) reported measurements at the Old Angleton Road bridge, not the railroad bridge (see Fig. 8). (In Fig. 13, the Old Angleton Road bridge would be to the west, behind the

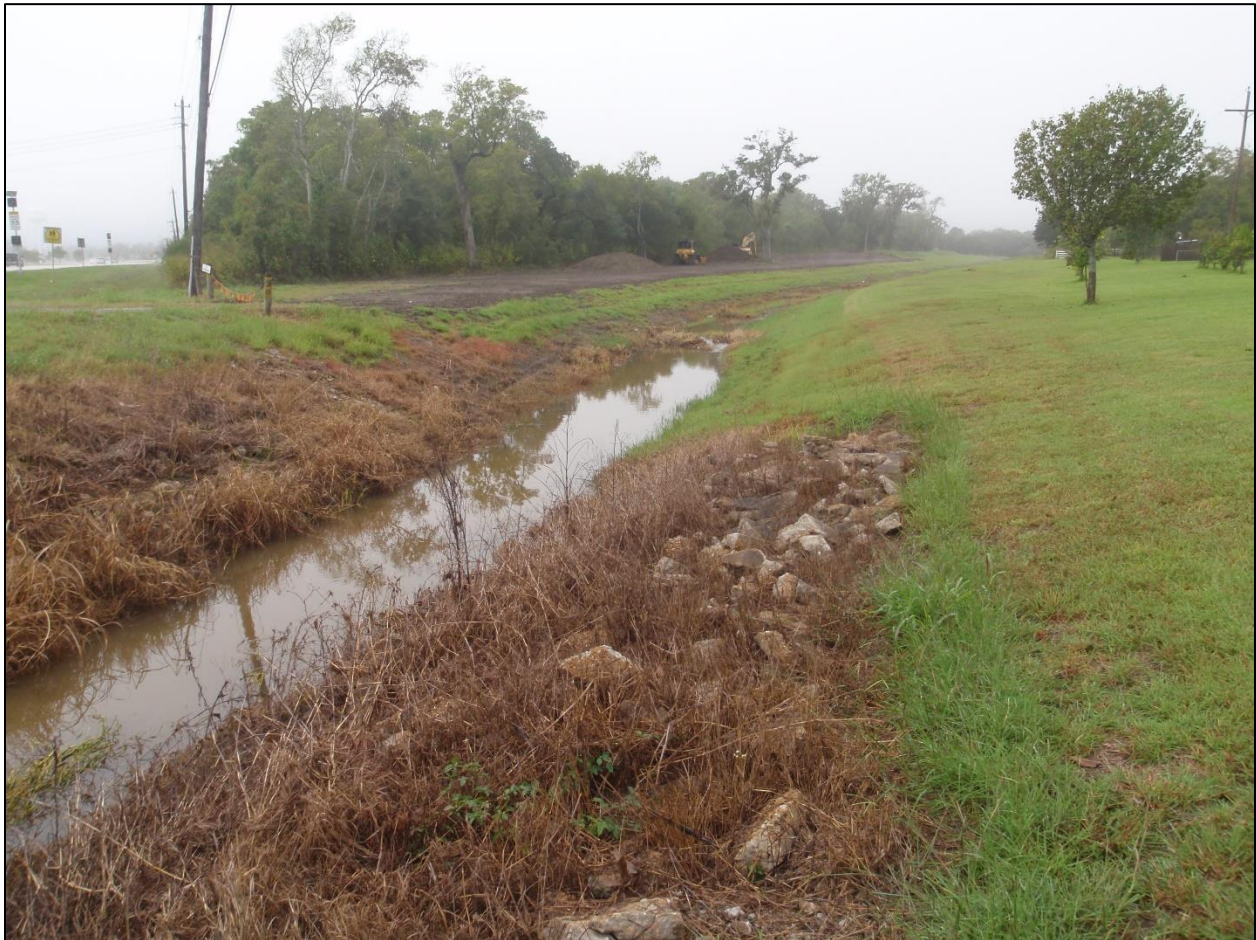
Figure 14a. Typically, water flows westward (away from the viewer) through the “East Ditch” to Bastrop Bayou (see Fig. 3). However, after diversion by the sandbag dam, water most likely flowed eastward through the same ditch toward FM2004 (see Figs. 10-11). View looking to the southwest. Photo taken by the author on October 30, 2019.

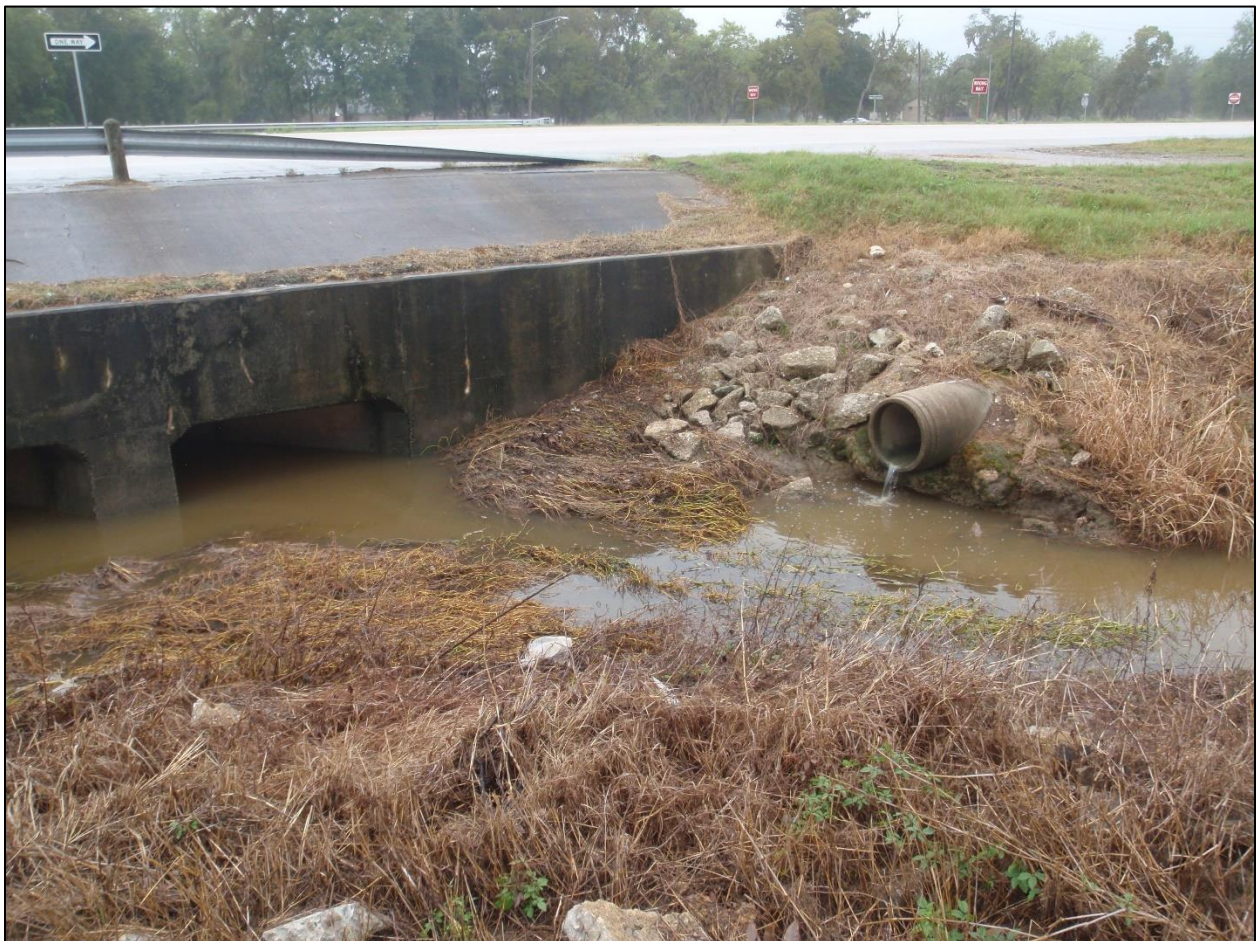
Figure 14b. Typically, water in the “East Ditch” flows from the south side of FM2004, through the culvert under FM2004, and then westward (toward the right in the photo) to Bastrop Bayou (see Fig. 3). However, after diversion by the sandbag dam, water most likely flowed eastward through the same ditch (see Figs. 10-11) and emerged on the south side of FM2004 (opposite side of highway in background of photo). View looking to the south. Photo taken by the author on October 30, 2019.

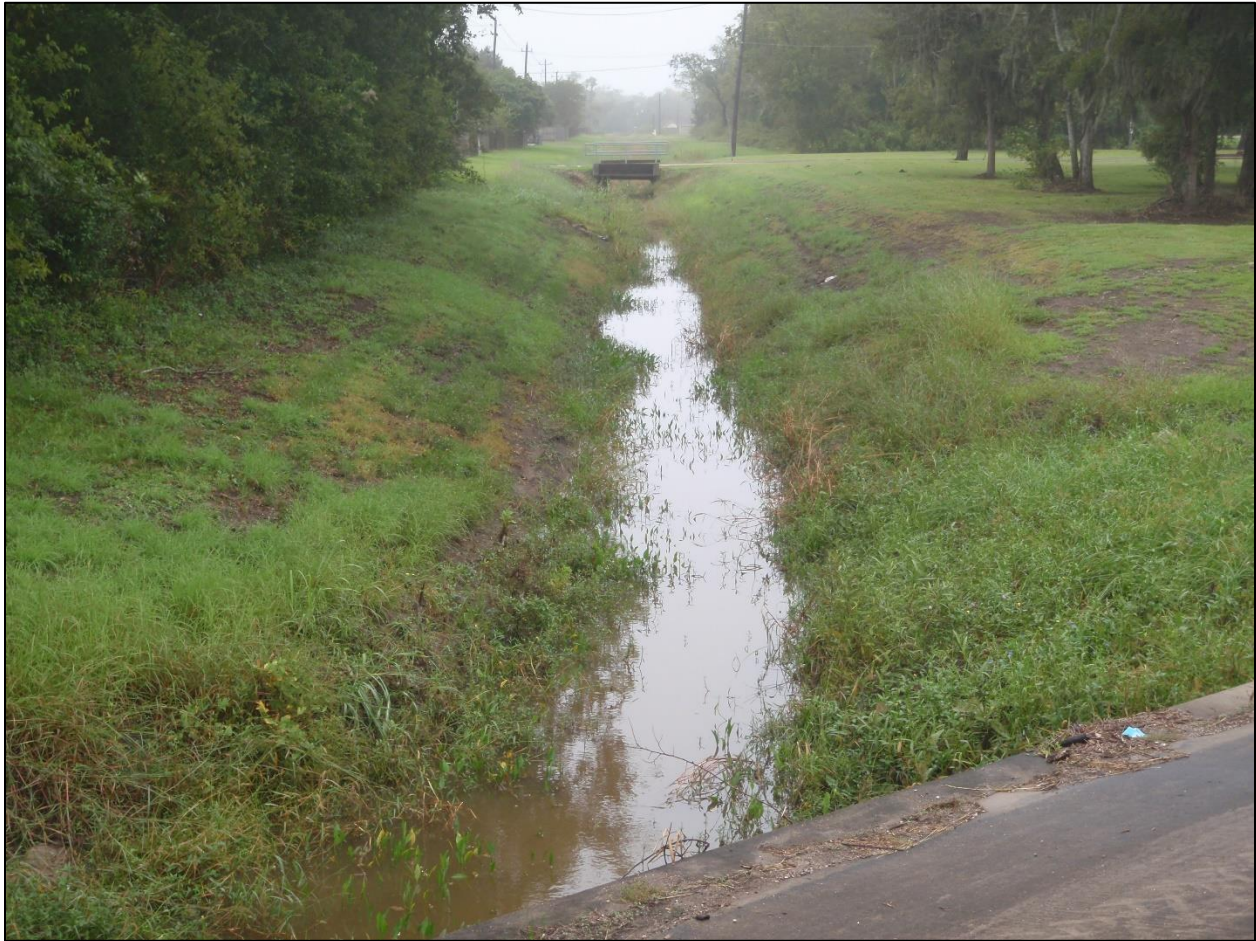
Figure 14c. Typically, water in the “East Ditch” flows northward (toward the viewer) from the south side of FM2004, through the culvert under FM2004, and then westward to Bastrop Bayou (see Fig. 3). View from the south side of FM2004 (note highway in foreground) looking to the south. However, after diversion by the sandbag dam, water most likely flowed eastward through the same ditch, through a culvert under FM2004, and emerged on the south side of FM2004 (see Figs. 10-11). The ditch is close to an interior boundary of the city of Richwood (Richwood on the right side of the photo). Photo taken by the author on October 30, 2019.

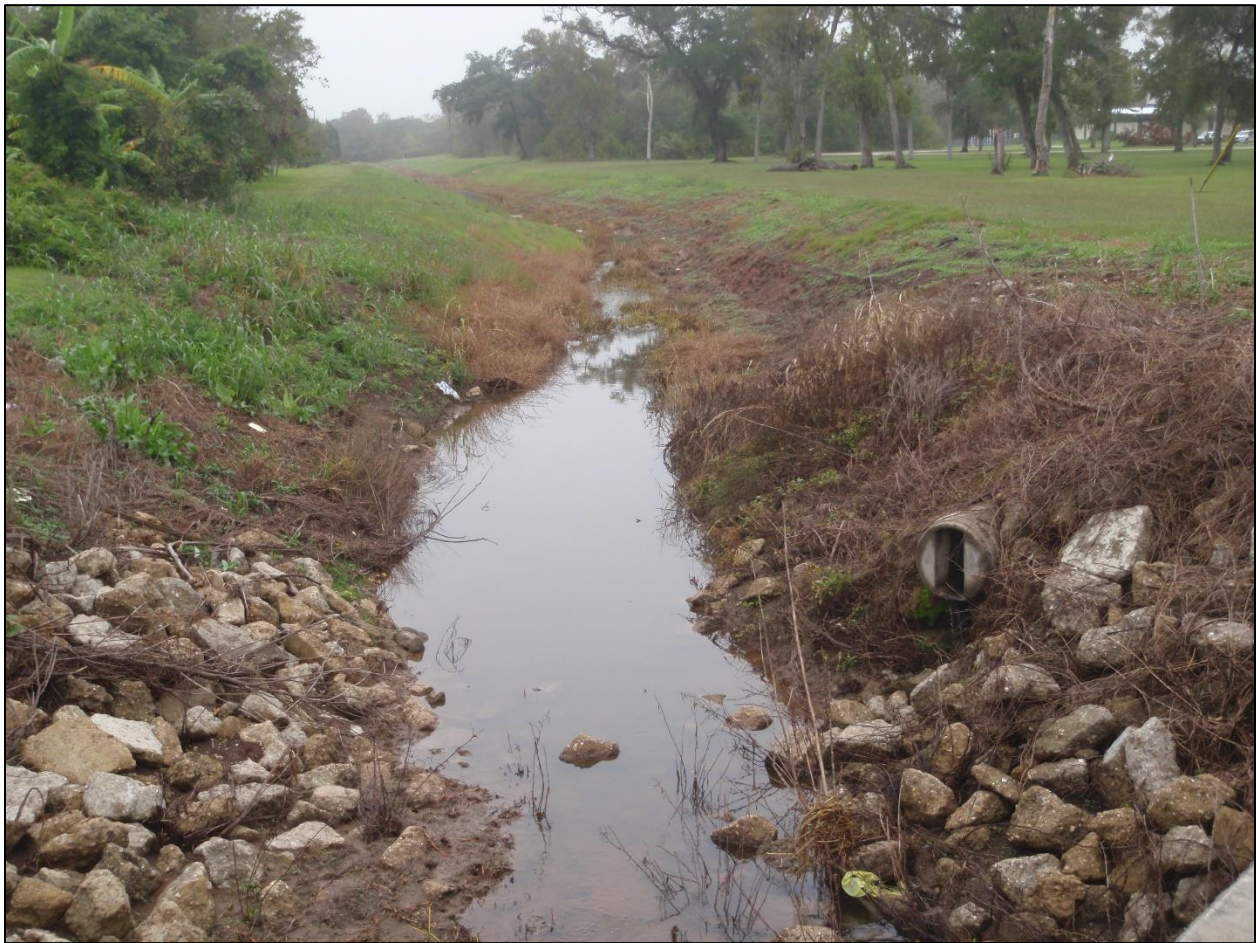
Figure 15a. Typically, water flows northward (away from the viewer) through the “West Ditch” to Bastrop Bayou (see Fig. 3). However, after diversion by the sandbag dam, water most likely flowed southward through the same ditch toward FM2004 (see Figs. 10-11). View from the north side of FM2004 looking to the north. Photo taken by the author on October 30, 2019.
