The Impact of Pumping and Sandbagging by the City of Lake Jackson on Flooding in the City of Richwood and other County Areas following Hurricane Harvey

Steven H. Emerman, Ph.D., Malach Consulting, LLC, 785 N 200 W, Spanish Fork, Utah 84660, USA, Tel: 1-801-921-1228, E-mail: SEmerman@gmail.com

Submitted to Matías J. Adrogué, PLLC, and Harrell & Nowak, LLC, on February 26, 2019

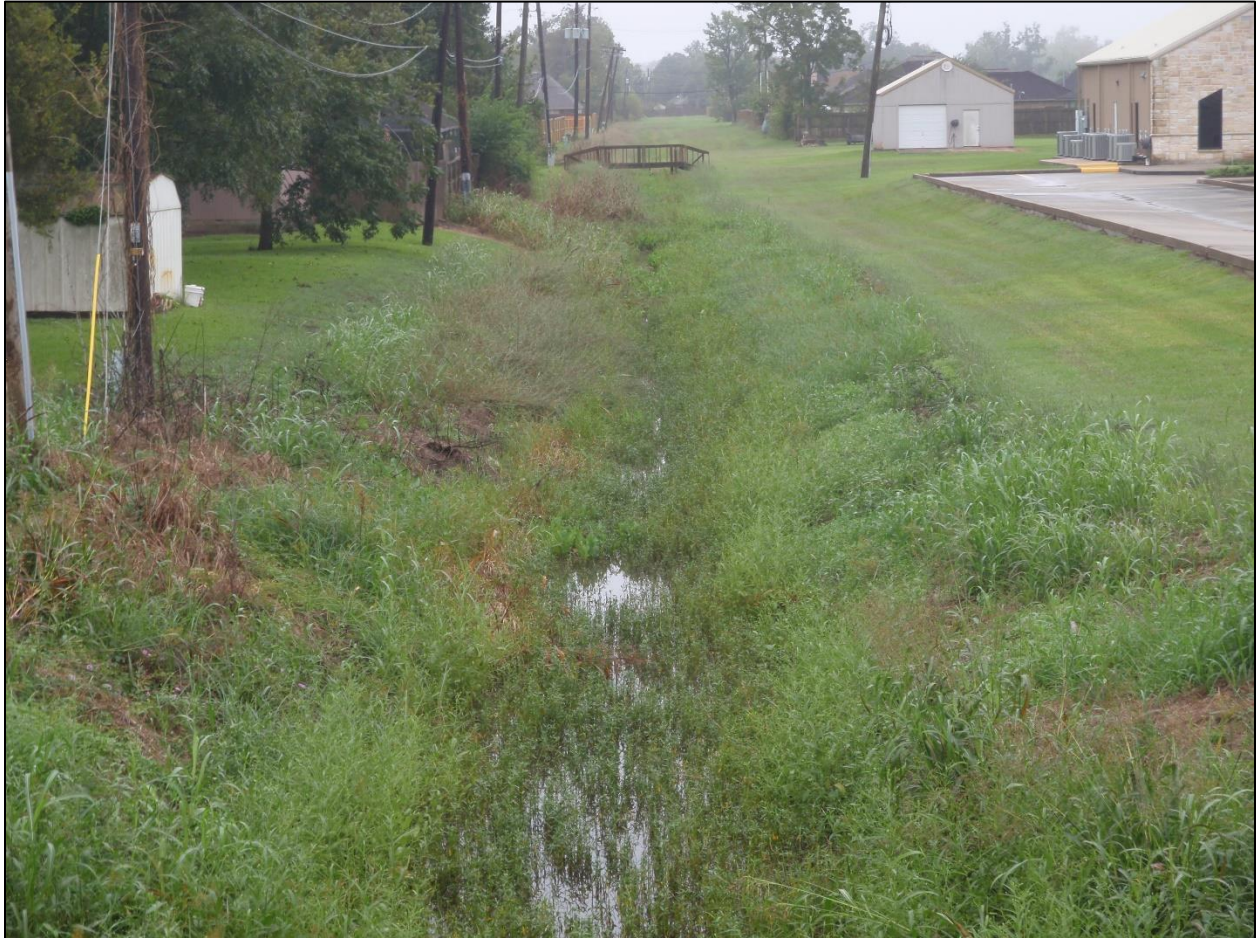
Figure 15b. Typically, water in the “West Ditch” flows northward (toward the viewer) from the south side of FM2004, through the culvert under FM2004, and then northward to Bastrop Bayou (see Fig. 3). View from the south side of FM2004 looking to the south. However, after diversion by the sandbag dam, water most likely flowed southward through the same ditch, through a culvert under FM2004, and emerged on the south side of FM2004 (see Figs. 10-11). The ditch is close to the boundary of the city of Richwood (Richwood on the left side of the photo). Photo taken by the author on October 30, 2019.

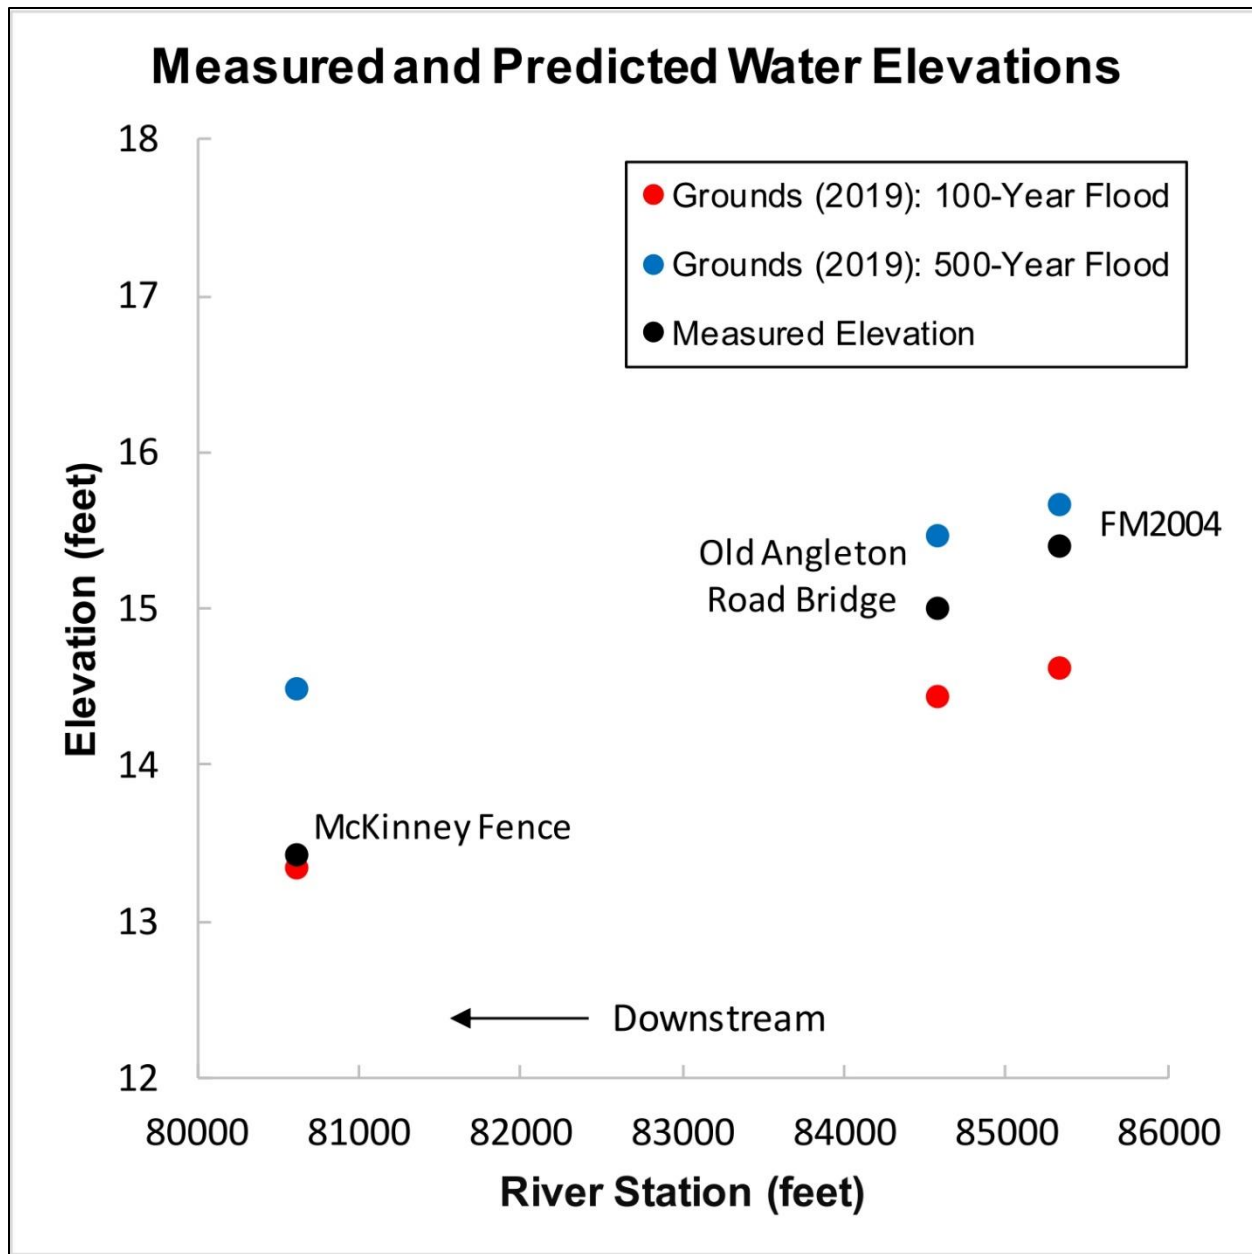
Figure 17. Water-surface elevations measured at three locations (see Table 1 and Fig. 16) were compared with the predictions of Grounds (2019) for combining pumping and a sandbag dam with the 100-year flood and the 500-year flood. At the two upstream sites, the measurements were between the predictions for the 100-year and 500-year floods (closer to the 500-year flood). However, at the McKinney fence, the measured elevation (13.42 feet) was nearly equal to the predicted elevation for only the 100-year flood (13.33 feet). Although the measured elevations are not consistent with the model of Grounds (2019), they are qualitatively consistent with the flood path that was reconstructed in this report (see Figs. 10-11). The McKinney property was not flooded by a simple overflow of Bastrop Bayou, but by a flood wave traveling along the southern floodplain of the bayou (see Figs. 9-10). This flood wave should have had a lower water-surface elevation than the bayou.

The measured watermarks and water-surface elevations are generally not consistent with the HEC-RAS model (Grounds, 2019) because they show a much steeper drop in the water surface along Bastrop Bayou than was predicted by the model (see Fig. 17). At the farthest upstream site (FM2004 north frontage road), the measured water-surface elevation was 15.39

feet, while the HEC-RAS model predicted an elevation of 14.61 feet for a 100-year flood and 15.65 feet for a 500-year flood, so that the measurement was 75% of the way from a 100-year flood to a 500-year flood (see Fig. 17). At the next site downstream (Old Angleton Road bridge), the measured water-surface elevation was 15.0 feet, while the HEC-RAS model predicted an elevation of 14.43 feet for a 100-year flood and 15.45 feet for a 500-year flood, so that the measurement was 56% of the way from a 100-year to a 500-year flood (see Fig. 17). Finally, at the McKinney fence, the measured watermark elevation was 13.42 feet, while the HEC-RAS model predicted an elevation of 13.33 feet for a 100-year flood and 14.47 feet for a 500-year flood, so that the measurement was 8% of the way from a 100-year flood to a 500-year flood, or essentially equal to what would occur during a 100-year flood (see Fig. 17).

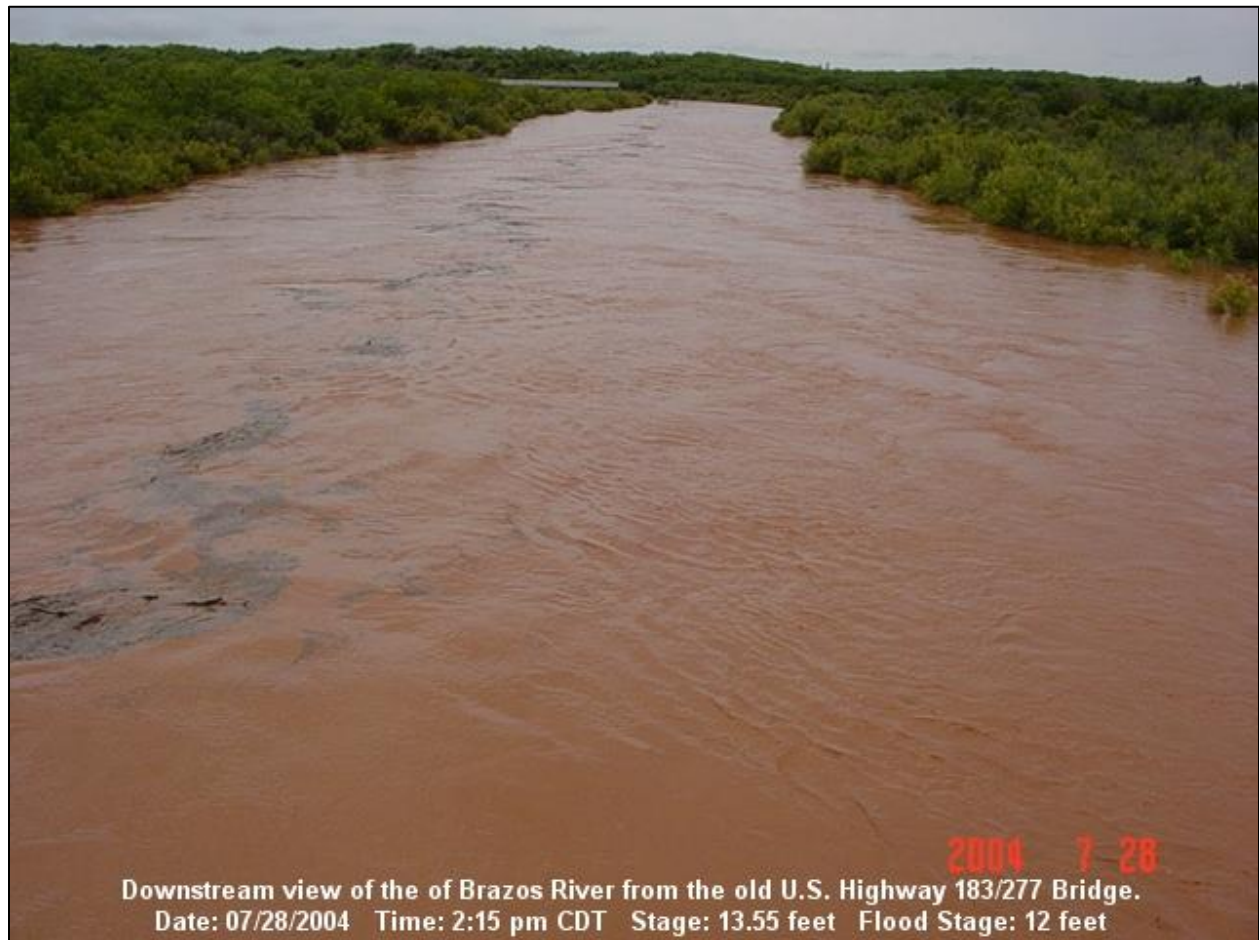
Figure 18. The Brazos River is well-known for its muddy water. This muddy water should have been visible in Richwood if the flooding in Richwood had resulted from an overflow of the Brazos River, as claimed by Grounds (2019). Photo from National Weather Service (2019).

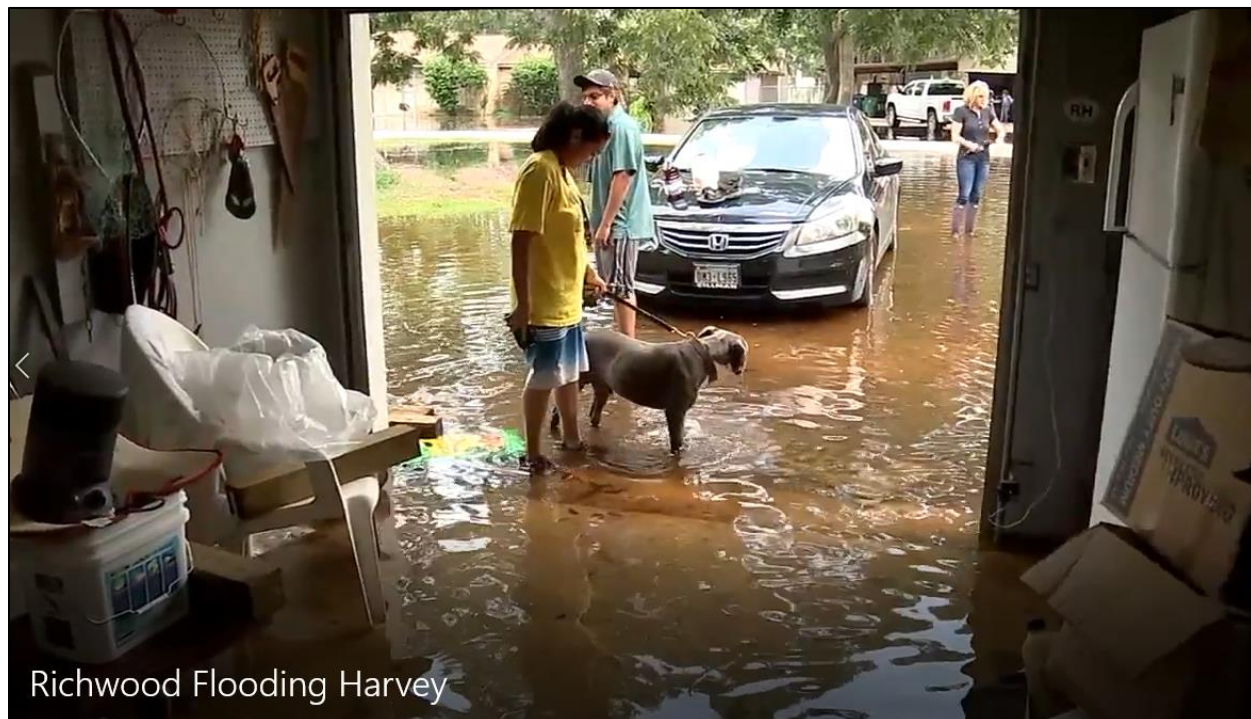
Figure 19a. Clear water is evident in the flooding of a garage and driveway in Richwood. The clarity of the water is indicated in the ability to see the surface of the garage floor and driveway. The clarity of the water draws into question the claim by Grounds (2019) that the flooding of Richwood resulted from the overflow of the Brazos River (compare with muddy water of Brazos River in Fig. 18). Still shot at 1:21 of video entitled “Richwood Flooding Harvey” produced by abc13 Eyewitness News (Barragan, 2017).

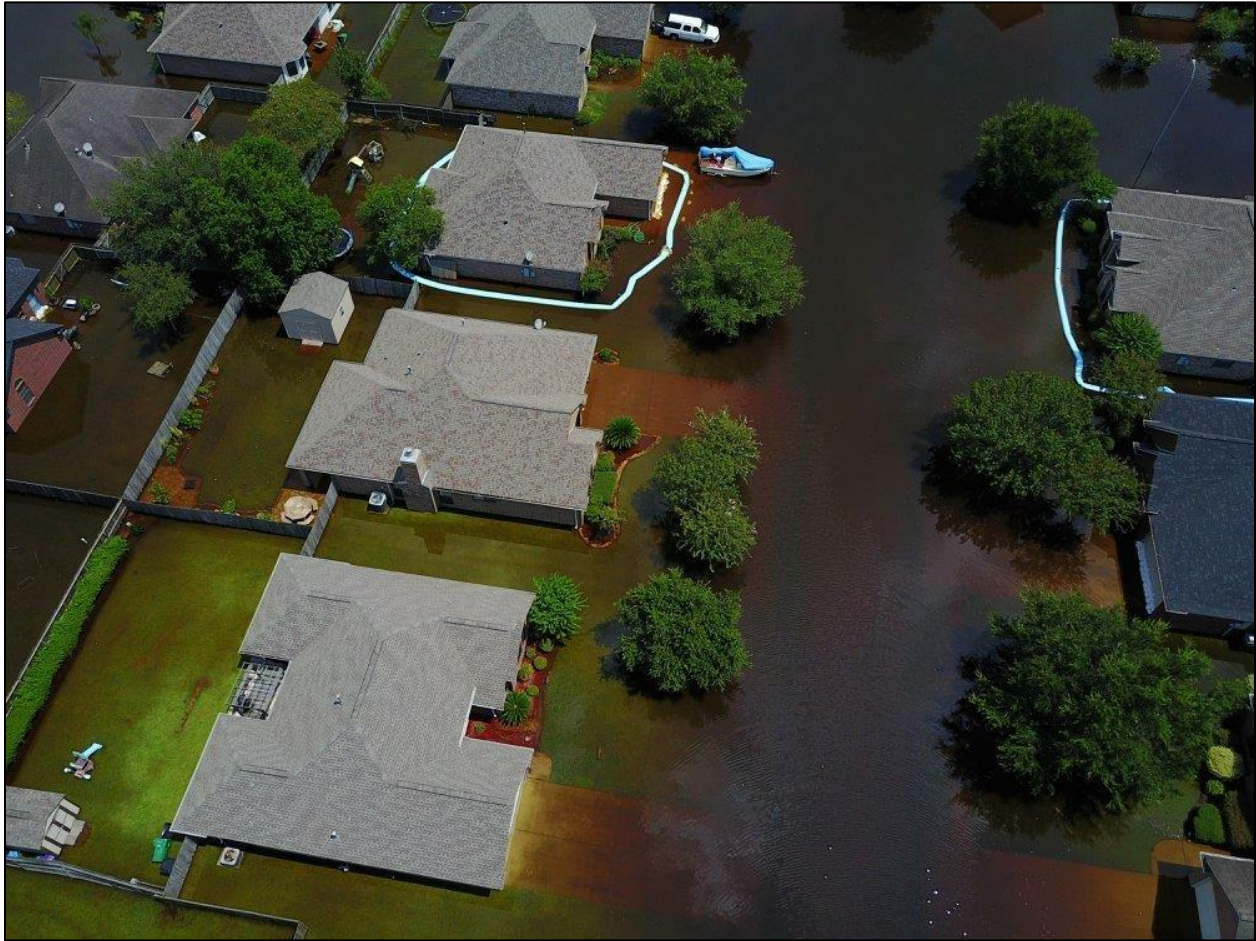
Figure 19b. Clear water is evident in the flooding of the streets and lawns in Richwood. The clarity of the water is indicated in the ability to see the driveway surfaces and the lawn grass. The clarity of the water draws into question the claim by Grounds (2019) that the flooding of Richwood resulted from the overflow of the Brazos River (compare with muddy water of Brazos River in Fig. 18). Still shot of drone video taken between August 30 and September 1, 2017, and provided by Matías J. Adrogué, PLLC.

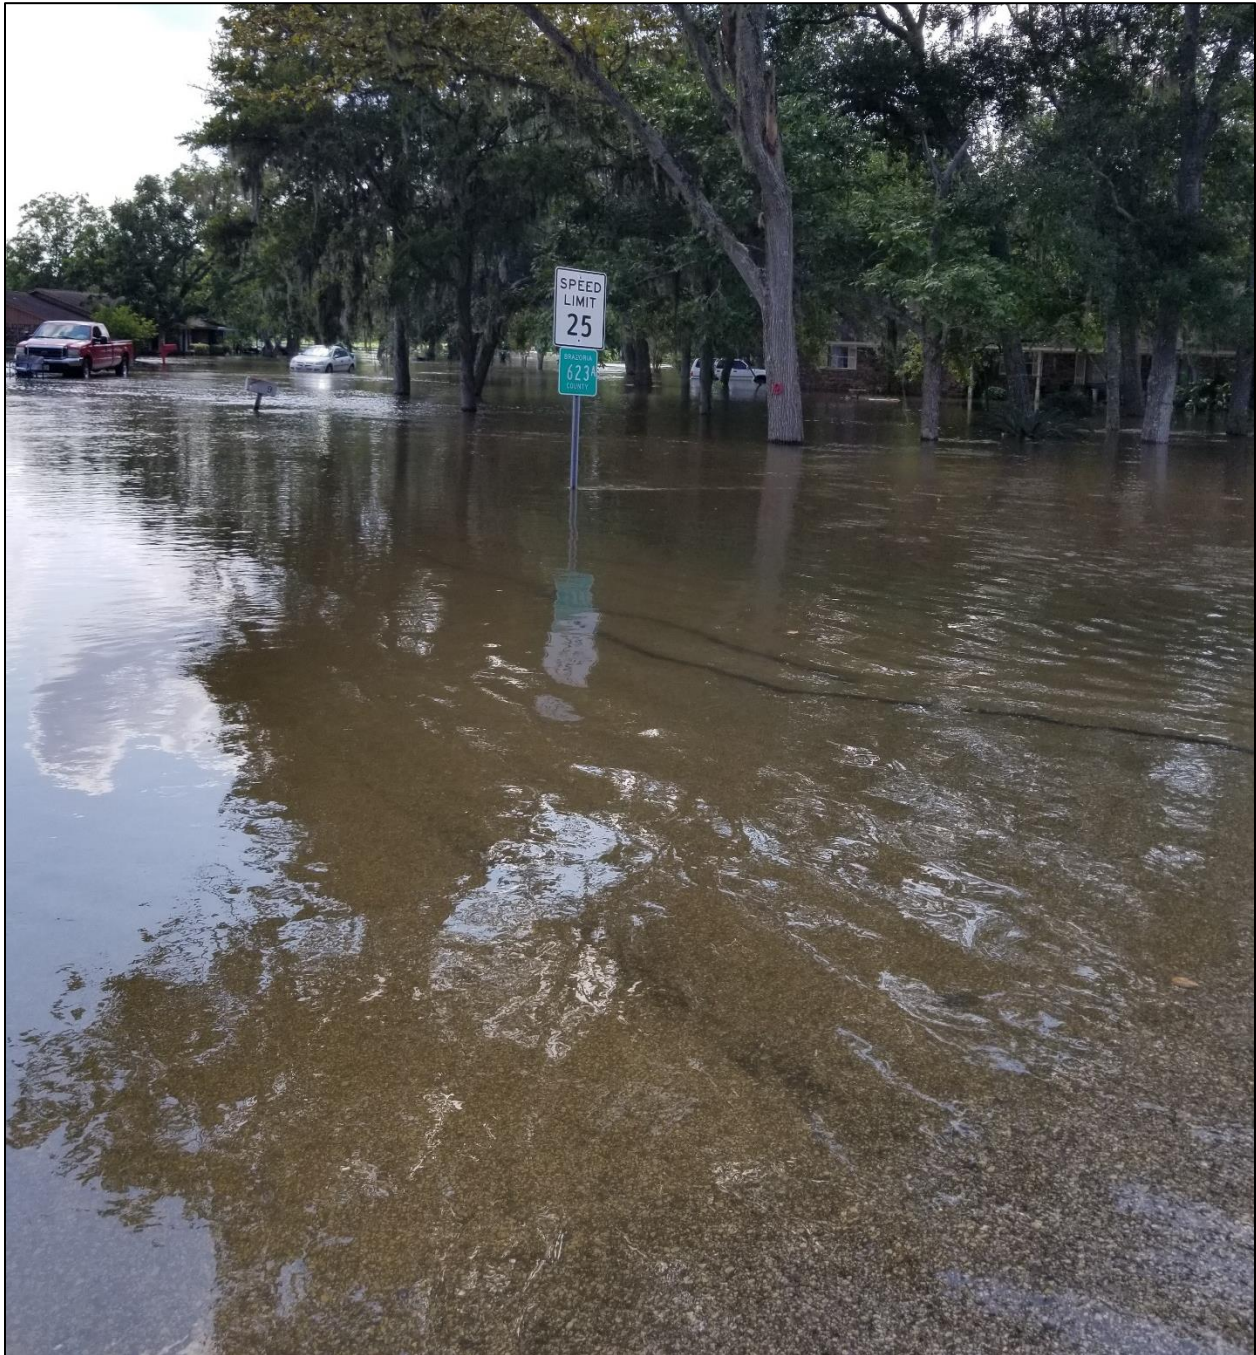
Figure 19c. Clear water is evident in the flooding of the streets and lawns in Richwood. The clarity of the water is indicated in the ability to see the street surfaces. The clarity of the water draws into question the claim by Grounds (2019) that the flooding of Richwood resulted from the overflow of the Brazos River (compare with muddy water of Brazos River in Fig. 18). Photo taken by Lance Wallace on September 3, 2017.

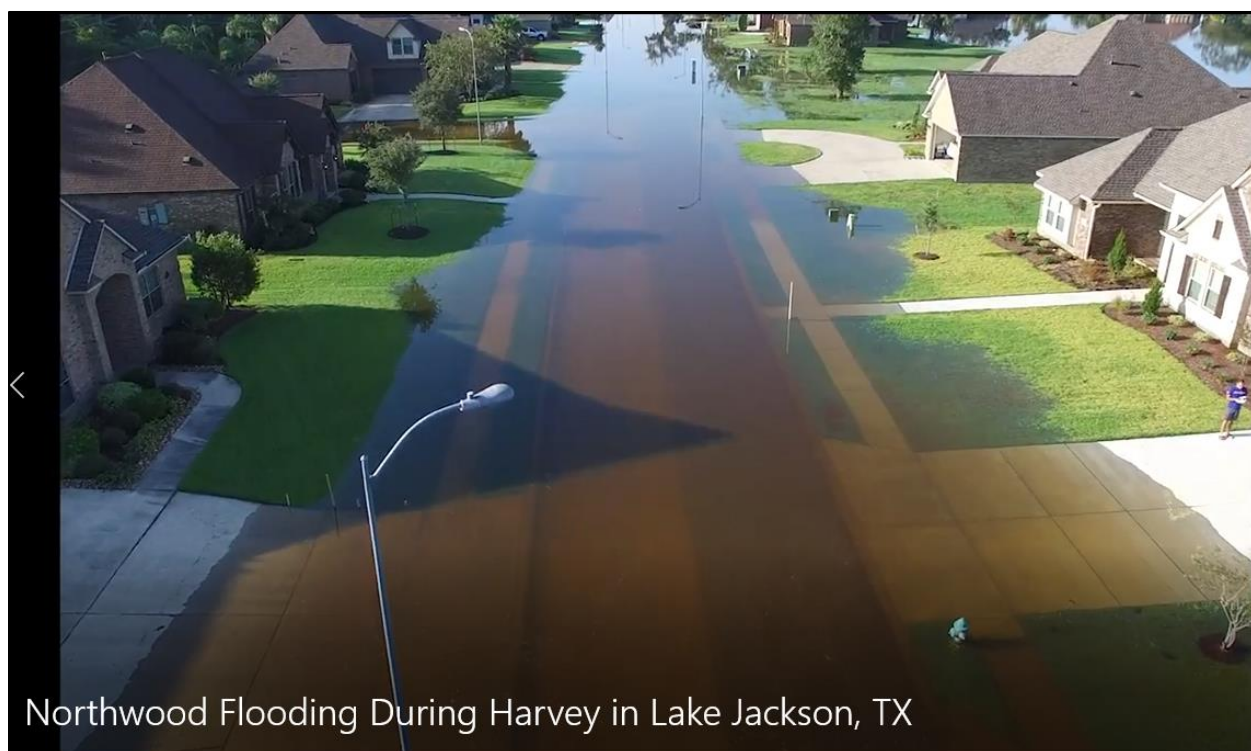
Figure 21. Clear water is evident in the flooding of the streets and lawns in the Northwood neighborhood of Lake Jackson (see Fig. 14). The clarity of the water is indicated in the ability to see the street and driveway surfaces, as well as the lawn grass. The clarity of the water draws into question the claim by Grounds (2019) that the flooding of either Richwood or Lake Jackson resulted from the overflow of the Brazos River (compare with muddy water of the Brazos River in Fig. 18). Still shot at 2:24 of drone video entitled “Northwood Flooding during Harvey in Lake Jackson, TX” (Tlath88, 2018).
