BERLIN Tyson plant

Technical Report Prepared by Ellen Silbergeld, Jim Hulbert, Jane Kreiter, and Jennifer Nyland

This project was undertaken to assist the Town of Berlin in assuring the safety of repurposing the former Tyson Poultry slaughter and processing plant. The site is now owned by the town of Berlin Maryland, which plans to redevelop the site for community recreational purposes. The issue under investigation by us related to the potential presence of pathogenic bacteria at this site related to its former use.

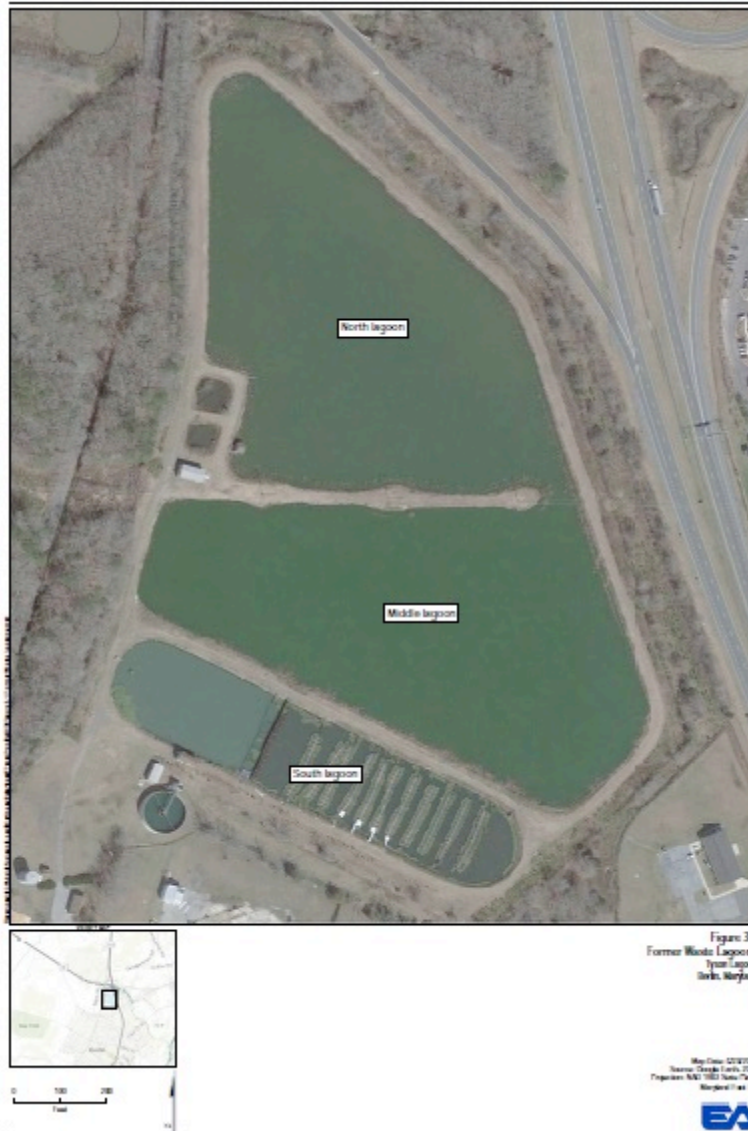
These ponds are shown below (map from EA). Reading from top to bottom of this figure, the slaughter house waste was first discharged into the round holding reservoir shown at the bottom. From there, liquids were pumped into the small pond with plant flotation devices. This pond drained into the larger pond at the top of the figure and eventually runoff was discharged into a natural stream on the right on the ponds.

The flow from the chicken processing plant went through a pretreatment facility that was located inside the existing building. The flow then went to the round clarifier that is located South of the South Lagoon. From there it entered the South Lagoon on the East side where it was aerated. Then it flowed to the other side of south Lagoon where the floating vegetated barges are. From the Southern lagoon the flow went to the middle lagoon and then to the North lagoon. Prior to discharge into Kitts Branch the effluent went through a filter which was located in the building on the land located

between the middle and north lagoons. Chlorination and dechlorination occurred in the small cells adjacent to the building

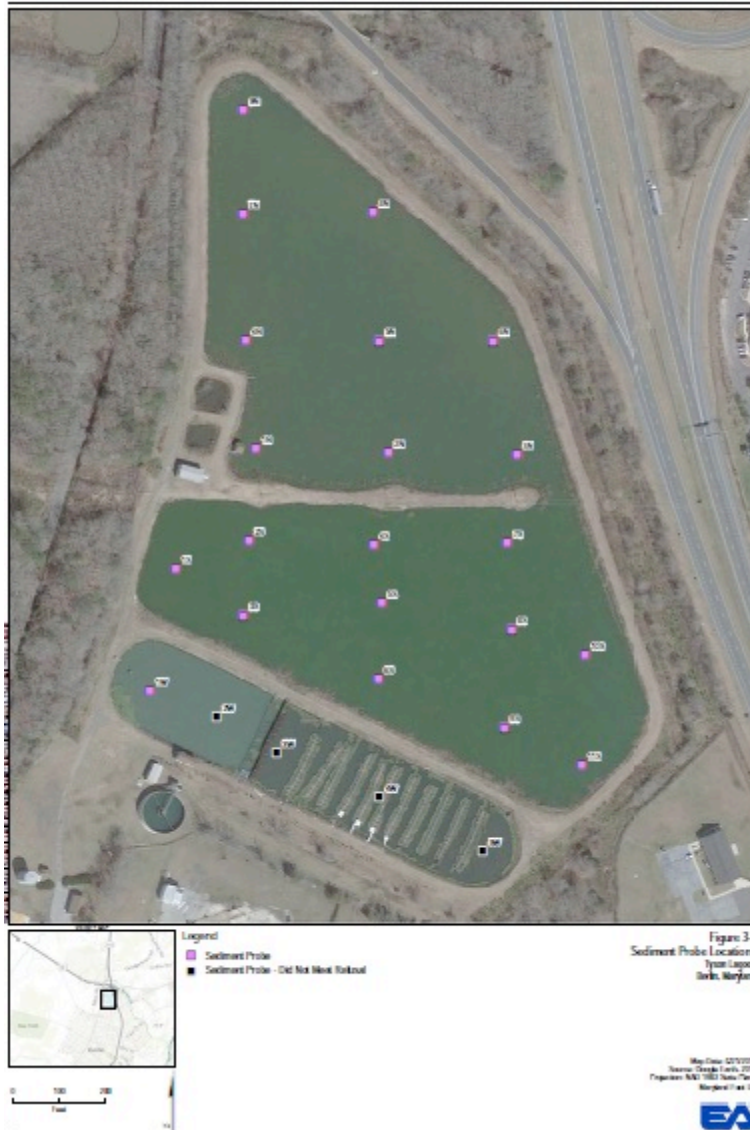
Using information provided by EA and the city of Berlin, we proposed to take sediment samples at three points within the first discharge pond on the map below. We did not sample from the holding reservoir since this structure will be filled in as part of the site remediation!

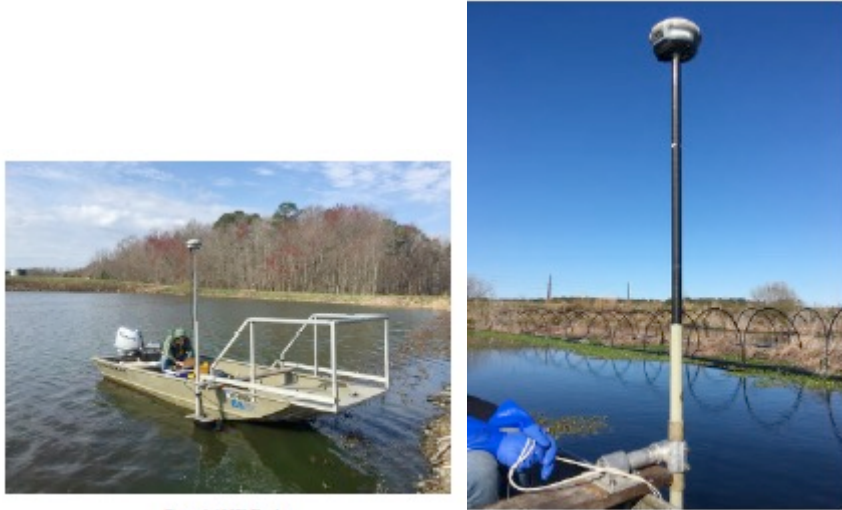
EA conducted a series of sediment probes at 25 pre-determined locations within the three wastewater management lagoons between 30 March and 31 March 2017. The probe data were used to identify the elevation of the water and sediment surfaces, as well as the elevation of the firm subgrade material at each location.

Additionally, two duplicate core samples were collected from the western half of the south wastewater lagoon (WWP-1.1; WWP-2.1) for the purpose of microbiological analyses. Sampling locations were located via GNSS by EA prior to sampling and are presented in Figure 2 above.
